SECTION II

Operations & Economics

5.0 TECHNICAL PERFORMANCE

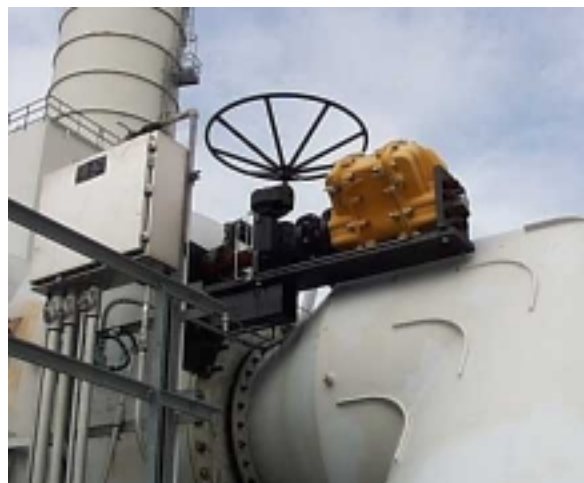
Figure 5.1.1B: Close-up of a Newly Installed Guide Vane Actuator

Actuators have been highly susceptible to weather conditions, the electronic controllers for the actuators have proved to be imprecise and difficult to manage, critical components have worn

quickly and repeatedly and replacement parts that should be commonplace have been difficult to procure. Furthermore, all of these difficulties have been compounded by the fact that the original equipment manufacturers for both the compressor and guide vane actuators have not been cooperative with regard to corrective actions. Future gasification projects requiring the installation of air compressors of this magnitude need to pay particularly close attention to the detailed design of the main air compressor's inlet guide vane subsystem.

The actuators on the inlet guide vane subsystem for the main air compressor were replaced in October 1999, with a new third party design (Figure 5.1.1B). Some of the benefits of the new actuators include the following. The new system is designed for all weather conditions, which should eliminate plant downtime associated with moisture. The new design completely eliminates the field electronics inherent with the old system, thus simplifying guide vane control. The new actuators are designed for more cycles of operation than the plant could reasonably require in the course of several decades. All three actuators have a mechanism to allow them to be manually positioned and locked anywhere within their full range of motion providing the capability to perform actuator maintenance while the main air compressor remains on line. The new system incorporates only parts made in the USA, thus reducing cost and delivery lead-times. All three stages now utilize identical components affording a reduction of spare inventory. The actuators have caused no downtime since installation, and are expected to eliminate the air separation unit's largest source of downtime.

While installing the new inlet guide vane project for the main air compressor, all three of the guide vanes needed to be removed from the compressor for inspection and repairs. During this process several small improvement projects were implemented in order to prevent damage to the inlet guide vanes and reduce costs of future guide vane repairs. They include the addition of lift points to the large diameter second and third stage air pipe spools to reduce rigging and lifting efforts while increasing safety and the addition of drain valves for each guide vane flange to prevent internal guide vane corrosion. Also, new flanges were added to the compressor oil return line to improve access for future guide vane extractions. Finally, proper mechanical design was implemented via materials selection for the guide vane shaft and shaft key, providing future equipment protection.

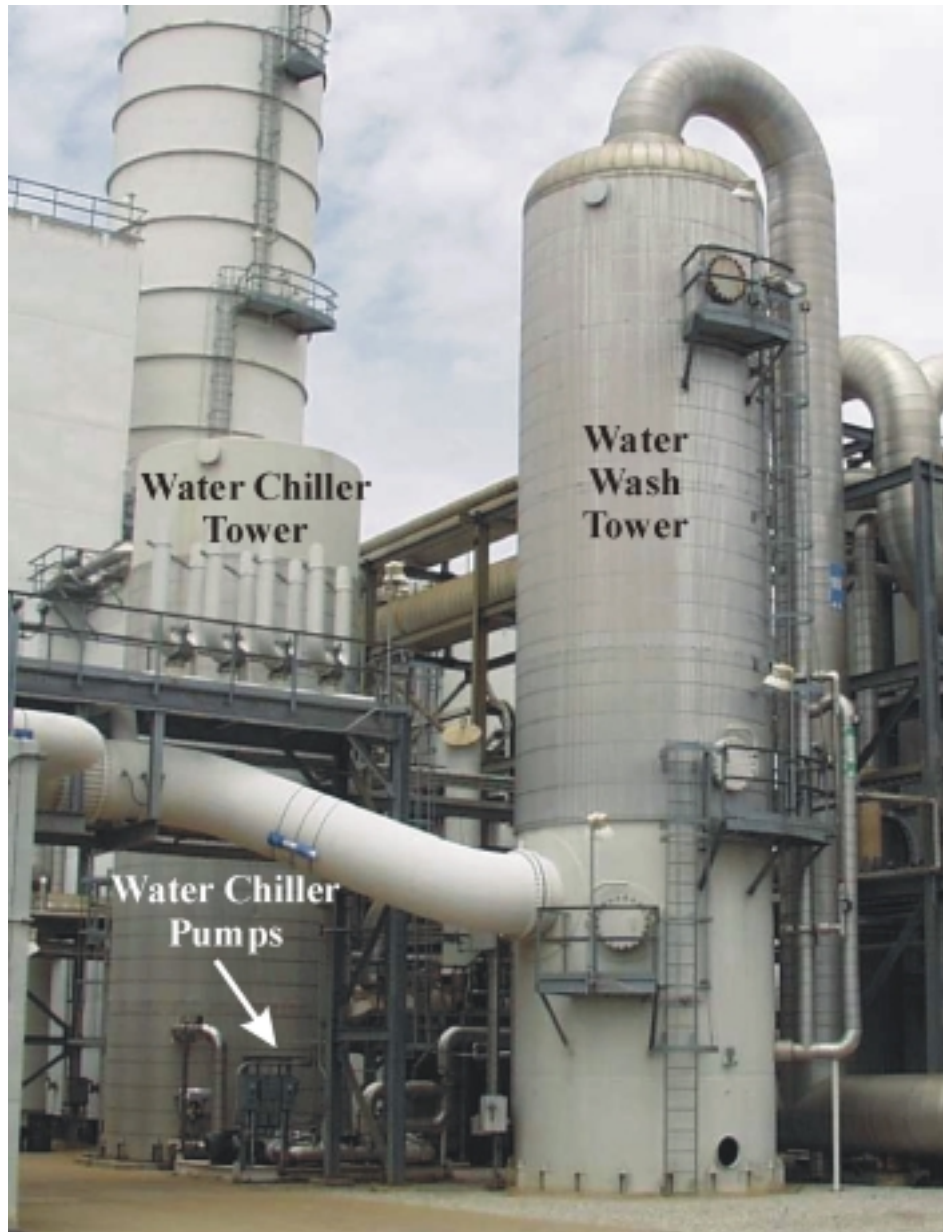
Figure 5.1.2A: Water Wash System

On June 8th and 9th, 1998 packing fires inside the water chiller tower were accidentally ignited from welding slag during vessel entry work. These fires accounted for all 61 hours of downtime attributed to the water wash system during the Operating Period. Evidence suggested the fires to be the result of inadequate usage of fire barriers while work was being performed, as well as failure to utilize a low energy welding technique. The use of heli-arc type welding in place of common stick welding and better usage of fire barriers will prevent recurrence of this incident if weld repairs inside the vessel ever need to be repeated.

It is also worth mentioning that corrosion of the vessel walls within the water chiller tower is occurring and will likely necessitate the replacement of the vessel several years in the future. It is unlikely that very much of the corrosion is taking place during plant operation, because the vessel is padded with waste nitrogen during those times. However, plant shutdowns allow air to contact the wet vessel internals. It would be wise to evaluate the cost of using an alternative material for the internals of the water chiller tower for future gasification projects.

The scope of work being performed in the water chiller tower at the time of the aforementioned fires was to correct oversight in the water distribution system design, repairing and reinforcing hardware within the tower. The water distribution system increases the efficiency of the water chiller tower by maximizing the contact between the water and the waste nitrogen. Years of operation with inadequate design had taken a toll upon the distribution system to the point that warmer water temperatures were beginning to limit the production of the air separation unit. As a result of the maintenance to the water chiller tower, water temperatures were significantly reduced, thus increasing oxygen and nitrogen production in the air separation unit.

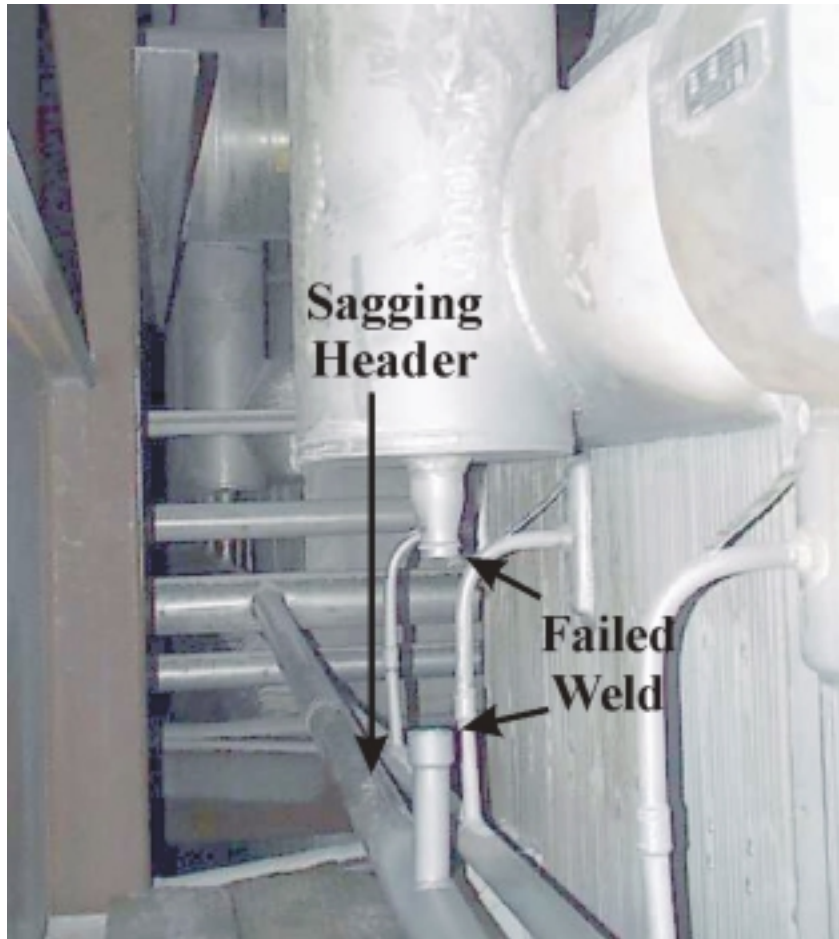
However, an air leak inside the enclosure that houses the main exchangers forced an unplanned outage resulting in 299 hours of lost production during the 3rd quarter of 1999. Repair of the leak required the complete removal of insulation inside the exchanger housing. The leak was the result of three failed welds on one of four identical headers within the exchanger enclosure (Figures 5.1.4C&D). The three process piping welds on each of the four headers provided the only structural support for the headers, causing the welds to be under constant stress. Furthermore, close inspection of the welds determined that they were not held to acceptable quality control standards during the original installation. Even the welds that had not yet failed displayed the potential for future problems if left uncorrected. The fact that these low quality welds were responsible for both the physical support of the headers as well as maintaining pipe integrity led the investigation team to conclude that equipment design and poor quality control methods employed during installation were the root causes of the incident. As a result, all twelve welds were re-worked and additional structural supports for each of the four headers were installed. No future downtime as the result of similar failures is expected, but it is worth noting that future installations of similar exchanger systems need to incorporate designs that provide sufficient structural support and maintain strict quality control standards when making cryogenic welds.

Figure 5.1.4C: Damage Inside Enclosure for Main Exchangers

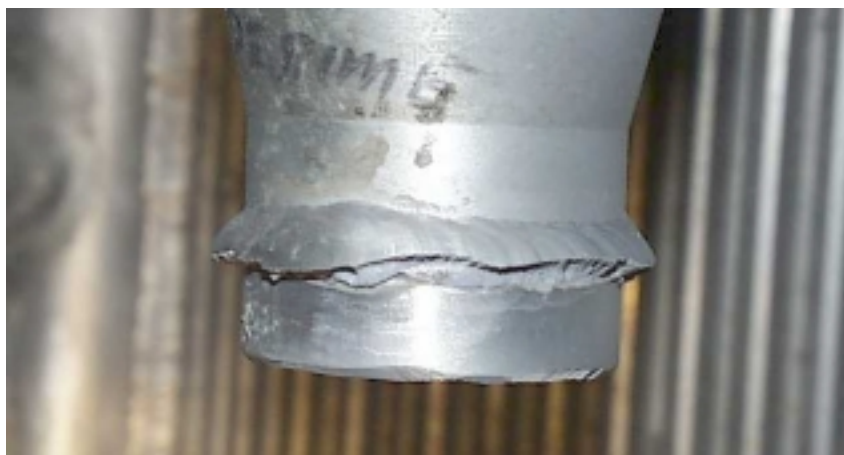
Figure 5.1.4D: Derime Header Failed Weld

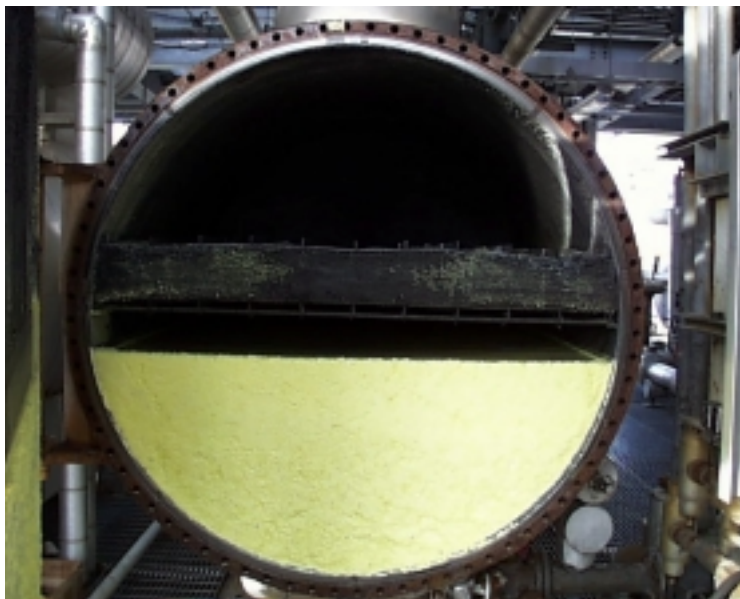
Figure 5.3.12B: Sulfur in No. 4 Sulfur Condenser as a Result of a Plugged Seal Leg

To reduce the maintenance costs associated with cleaning this piping, the welded steam unions to the steam jacketing were replaced with flanges. Additionally, to reduce costs associated with cleaning the seal leg, a clean out flange similar to that installed on the burner sulfur condenser seal leg has been installed.
