REPORTS OF DAMAGE TO JAPANESE
WARSHIPS - ARTICLE I

NAGATO(BB), KATSURAGI(CV), HARUNA(BB), AOBA(CA)
ISE(BB), AMAGI(CV), RYUHO(CVL), OYODO(CL)
TONE(CA), HYUGA(BB), ASO(CV), SUZUTSUKI(DD)

U.S. NAVAL TECHNICAL MISSION TO JAPAN

23 December 1945

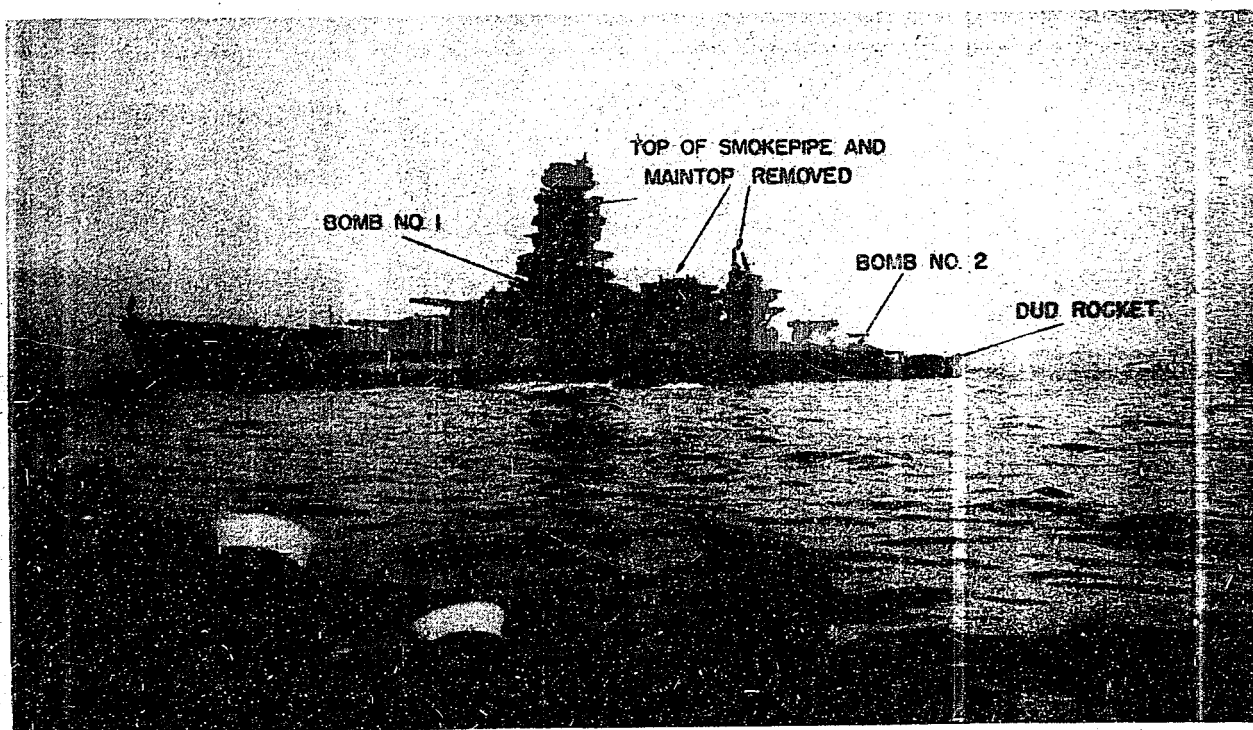
*Figure 1
At anchor. Smokepipe and maintop reported
removed during overhaul and repair period.*

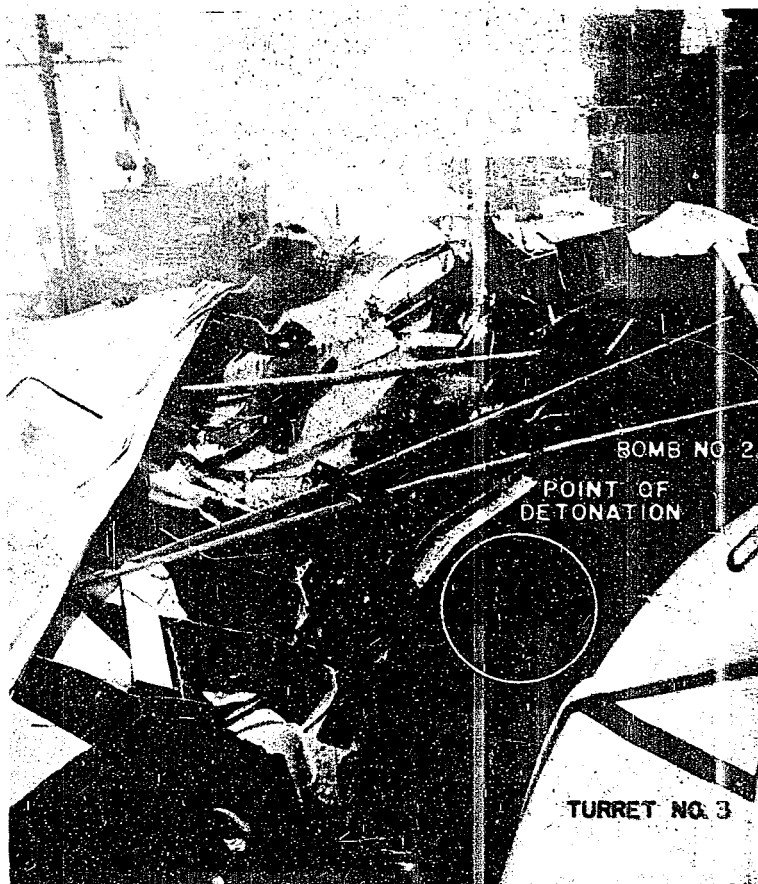
Figure 5
Looking to starboard at damage caused by Bomb No. 2. Blast extensive below superstructure (upper or forecastle) deck, arching latter some six to eight feet up for a length of 30 feet. Stores placed aboard after damage.

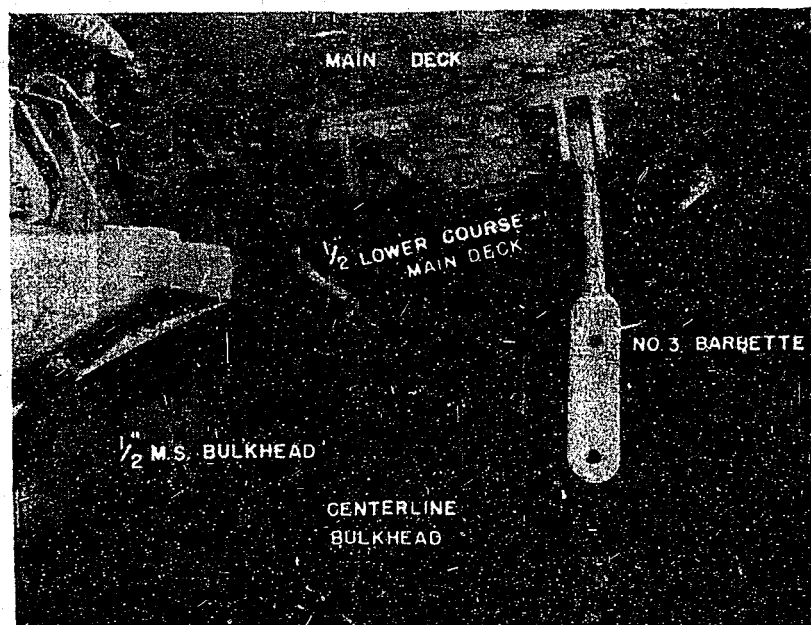
10. The compartment within which detonation occurred was large and sub-divided by partition bulkheads. Blast damage was particularly severe to the overhead, of relatively light (about 1/4" M.S.) plating. It was demolished over an area about 12 feet in diameter, but the intact portion forward of the hole was arched upward some six or eight feet. Deflection extended forward about 30 feet. The main deck, two courses of high tensile steel (1" over 1/2"), was deflected downward immediately below the point of detonation some 18 inches. The upper course was not ruptured and the connection of both courses to the barbette was not ruptured. The lower course, however, was ruptured (see Figure 6) in way of a longitudinal butt.

Figure 6
Looking to starboard under-
neath main deck. Main deck,
of two courses of 1" over
1/2" H.T. steel, deflected
downward about 18". Upper
course not ruptured. Lower
course ruptured as shown.
Point of detonation about
two feet above deck, ad-
jacent to barbette.

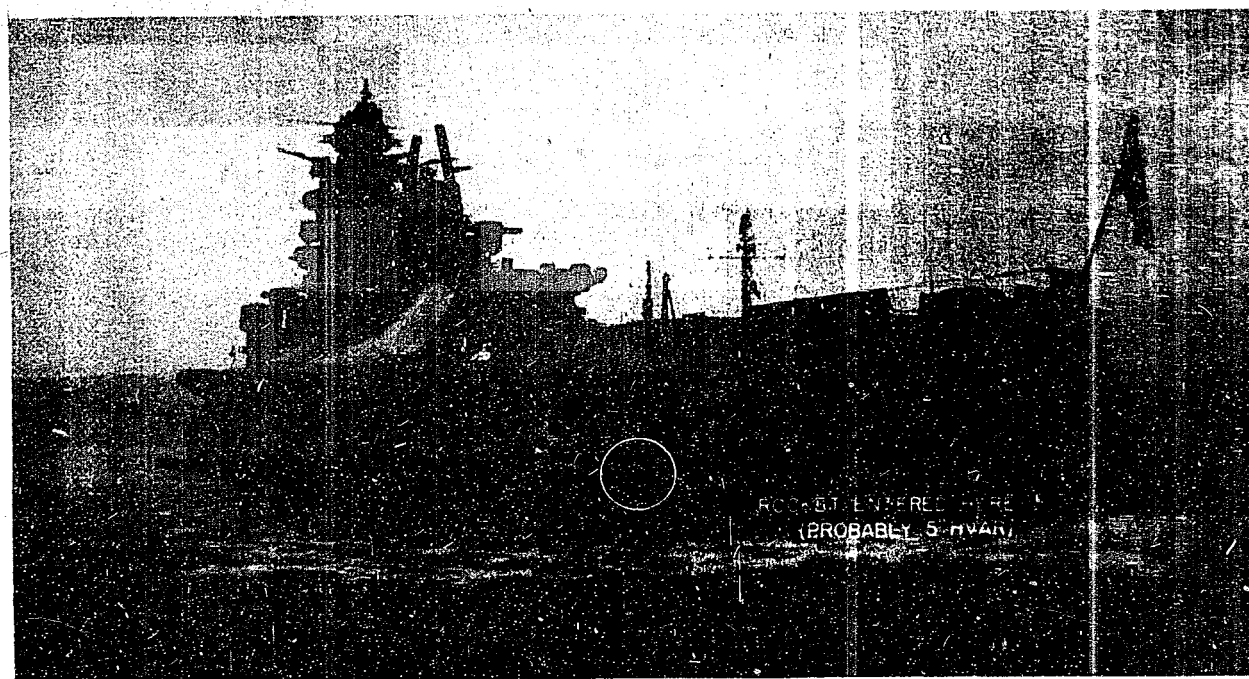
12. By reference to Photo 7 and Plate I, it will be noted that a missile struck the port quarter some four feet below the main deck. It emerged from the starboard shell somewhat higher (two feet below main deck), having struck nothing in its flight except the top of the Admiral's table on the port edge. This was gouged some two inches deep for a length of eight inches. It could have been a 5" HVAR rocket head which failed to detonate. It may have been

from some previous unreported attack, although this is unlikely as the Admiral certainly would have had his table repaired. The holes in the shell were readily patched. The sheathing on interior surfaces had not been patched. No rockets were included in the action reports available as having been employed against NAGATO, but rockets may well have been used and not reported.

Figure 7
Probably dud 5" rocket penetrated port shell and passed
completely through ship horizontally, emerging some-
what higher on starboard quarter and tearing hole in
starboard shell of same size (about 10" diameter). Two
holes in shell were most serious effects, although
Admiral's table-top was scarred.

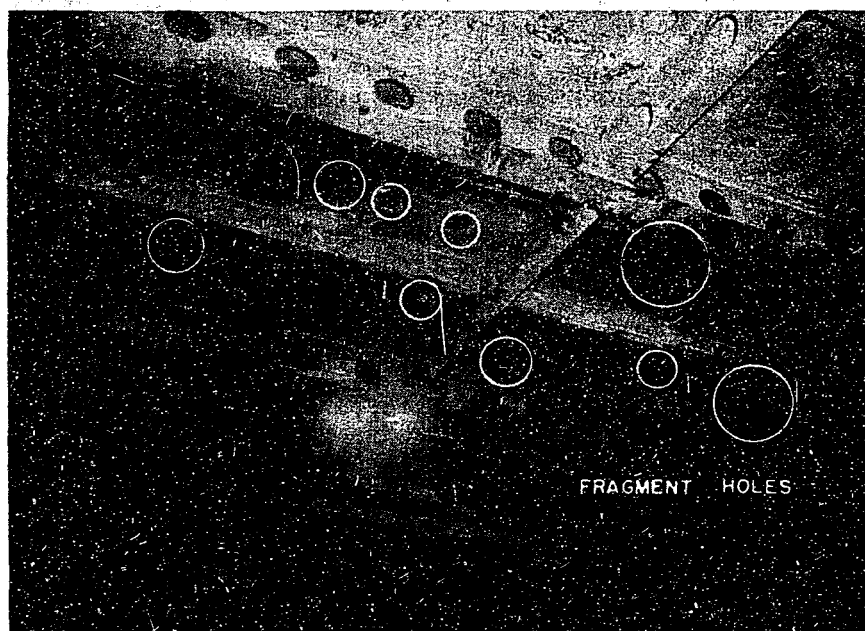
*Figure 9
Looking up at fragment holes in flight deck
from Bomb No. 1. Repairs in progress.*

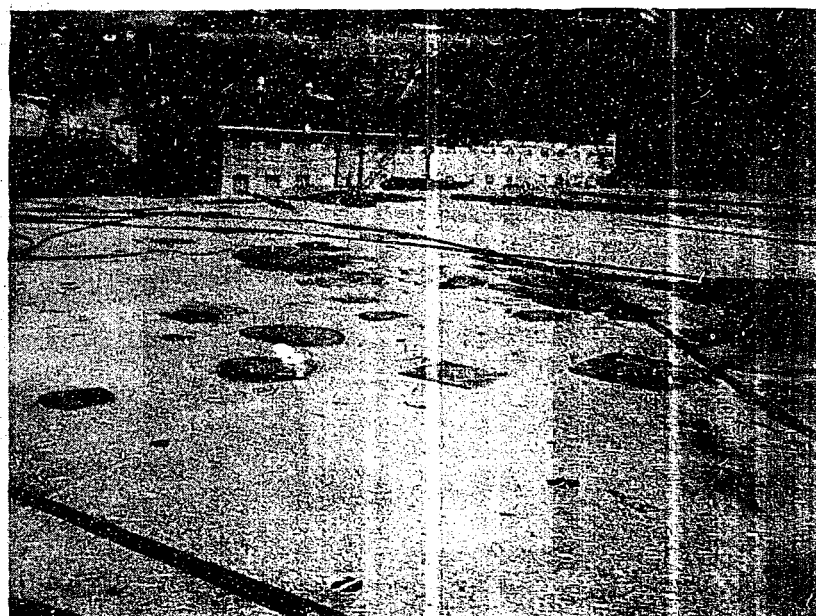
Figure 11
Patches over fragment holes in flight deck caused by Bomb No. 1.

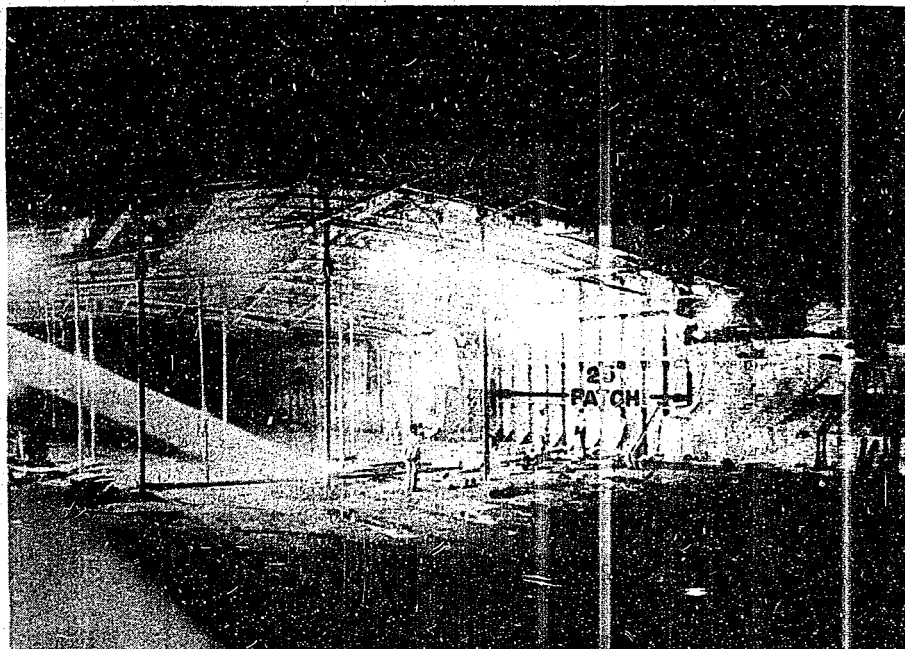
10. Bomb No. 2 caused extensive blast damage, as described. Despite the weakness of the flight deck with respect to blast from below, such extensive damage must have been the result of a large bomb. The large areas of flight deck and port hangar bulkhead which were demolished are also strong evidence of a large bomb. In view of these factors, it is estimated that Bomb No. 2 was a 2000-pound G.P. containing approximately 1000 pounds of TNT, with a tail fuze set for 0.01 sec. delay.

Figure 12
Damage from Bomb No. 2. Temporary repairs
in progress to make flight deck watertight.

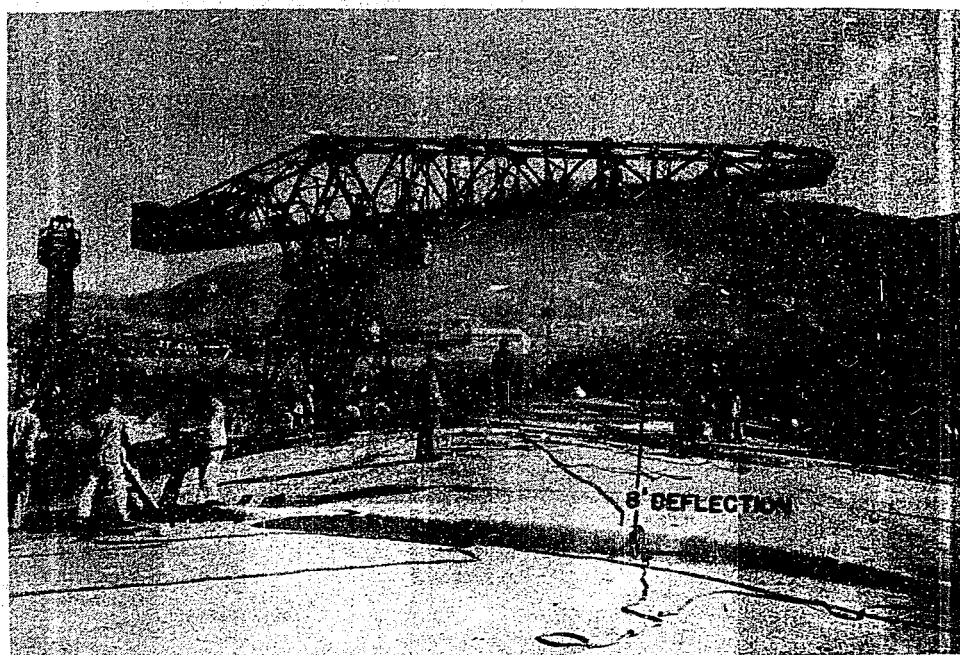
Figure 13
Damage from Bomb No. 2. Looking forward on flight deck.

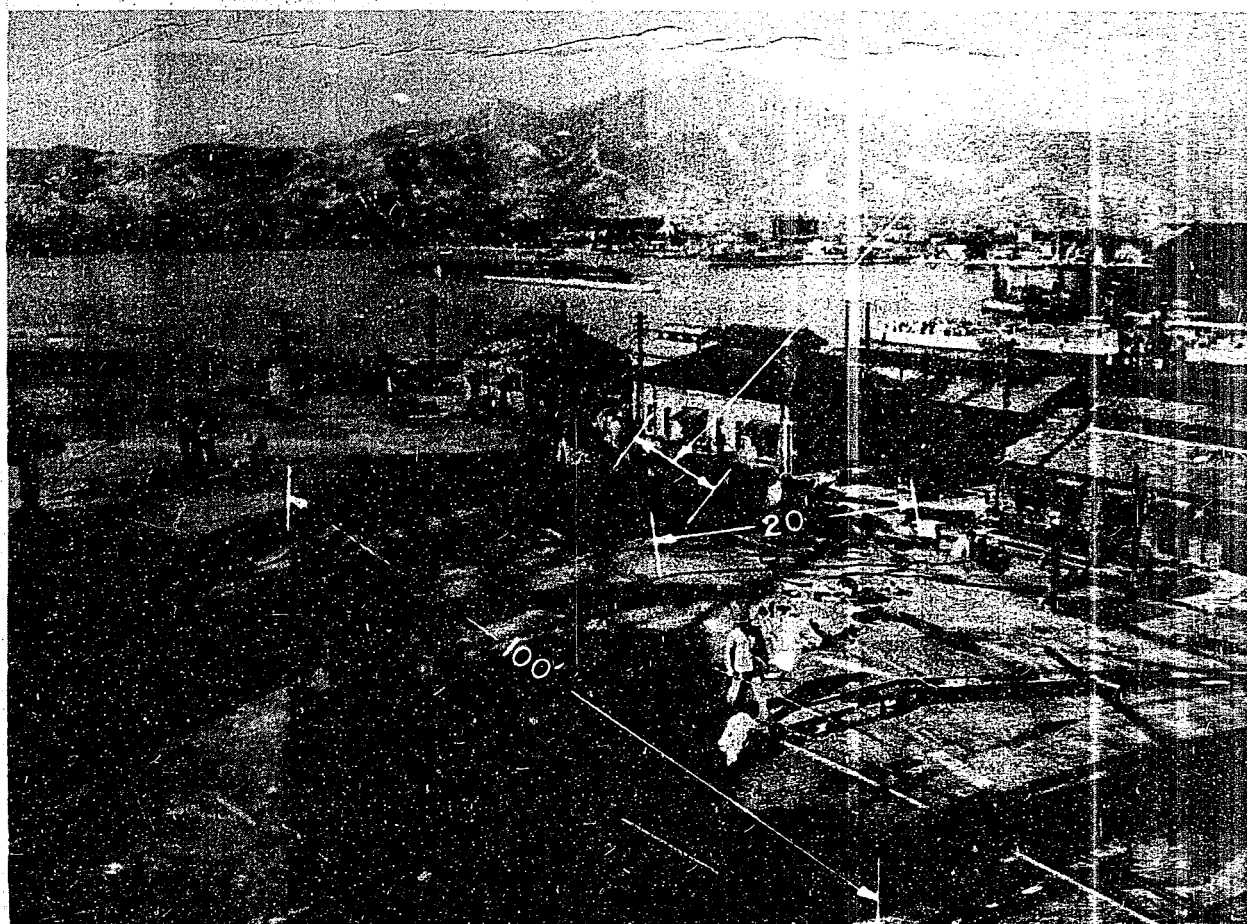
Figure 14
Looking down on flight deck from island. All damage shown caused by Bomb No. 2

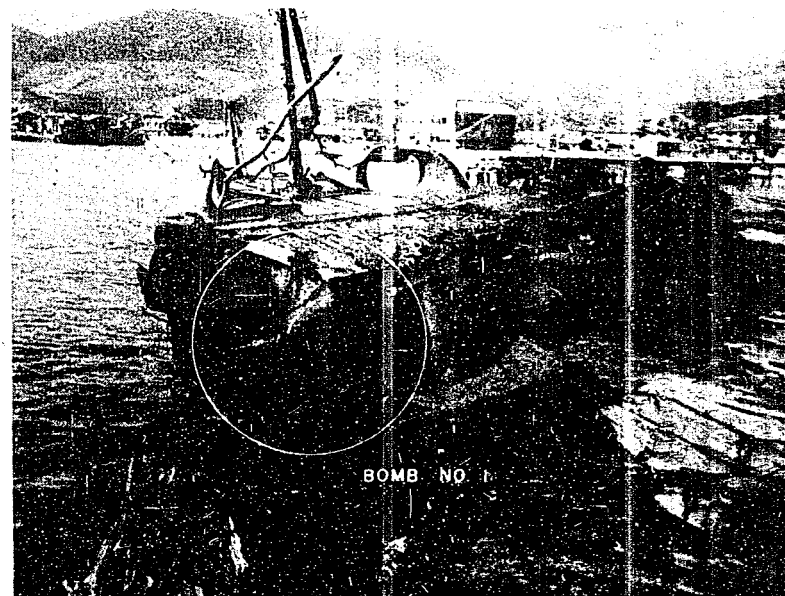
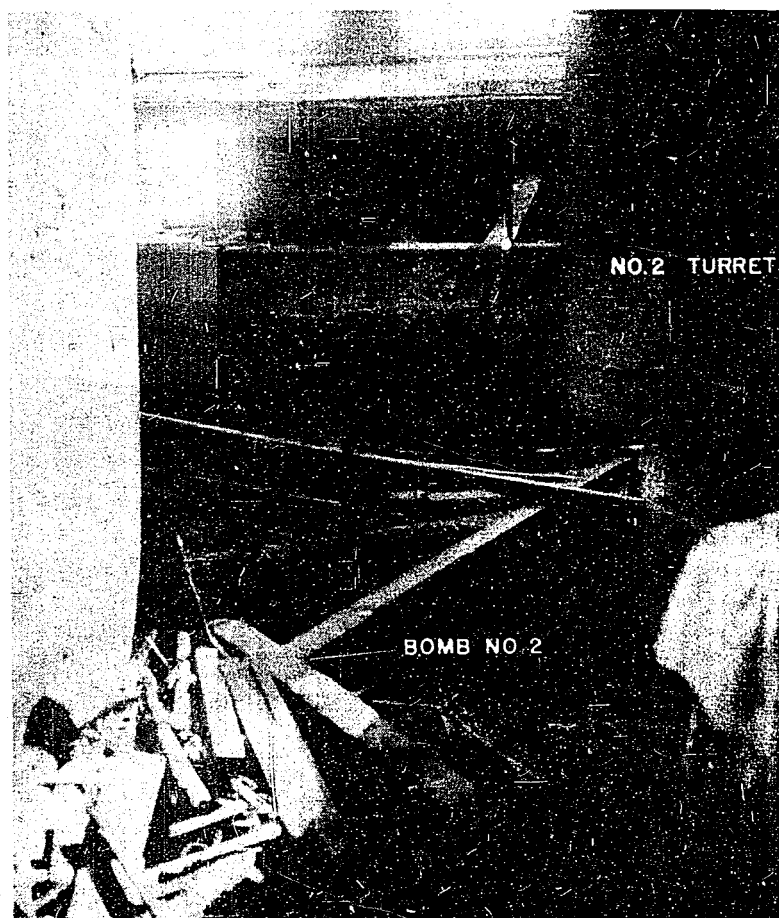
Figure 18
Damage from Bomb No. 2.

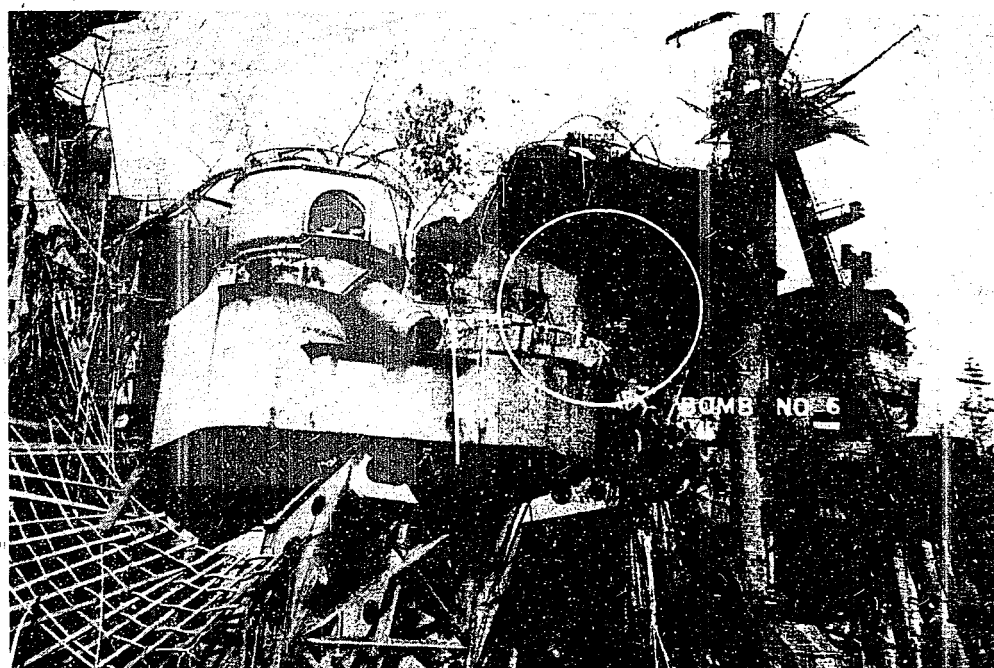
Figure 20
Damage to forward smokepipe from Bomb No. 6.

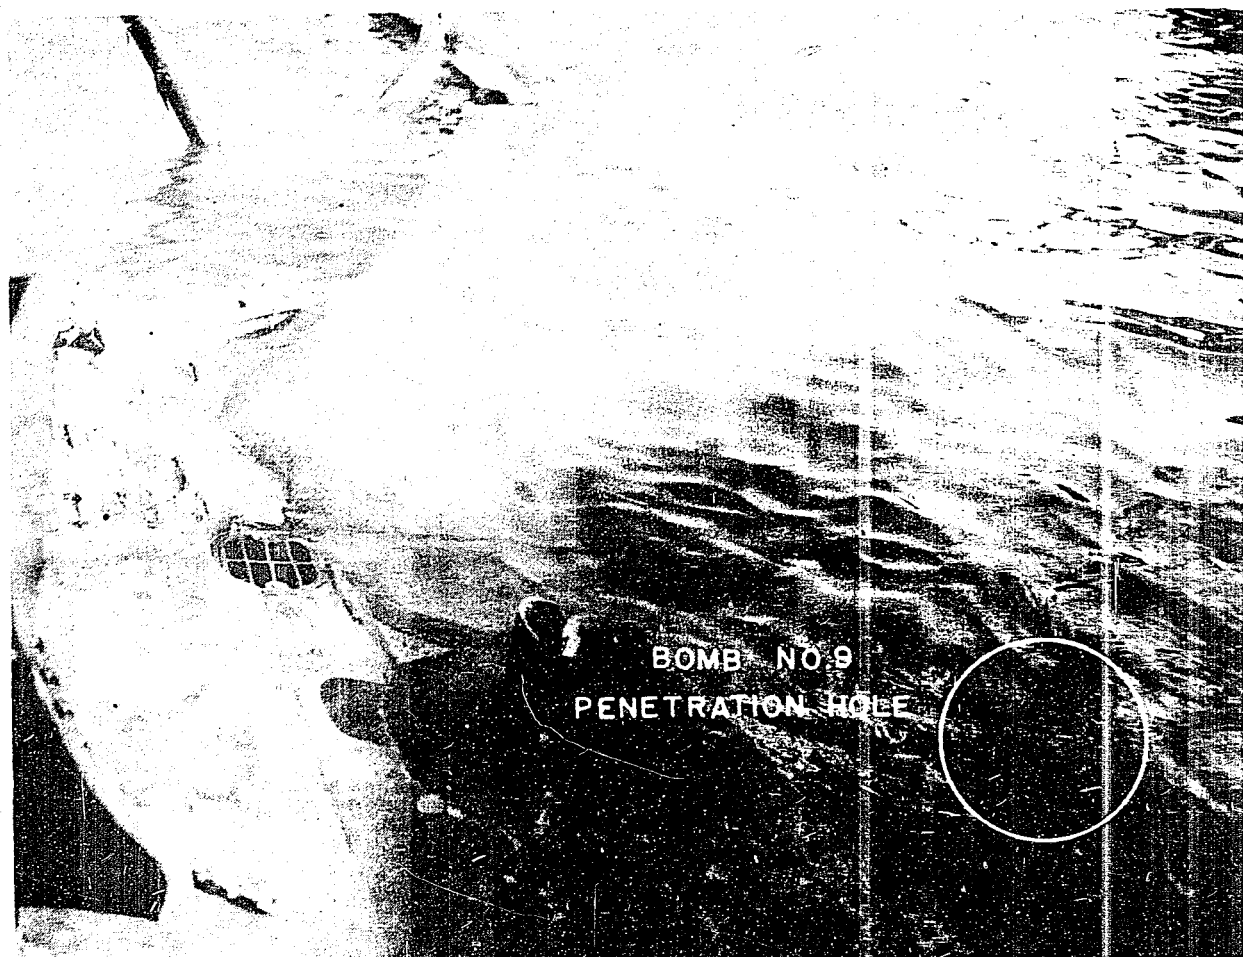
Figure 21
Bomb entry hole - 19½ inches - upper deck, aft.

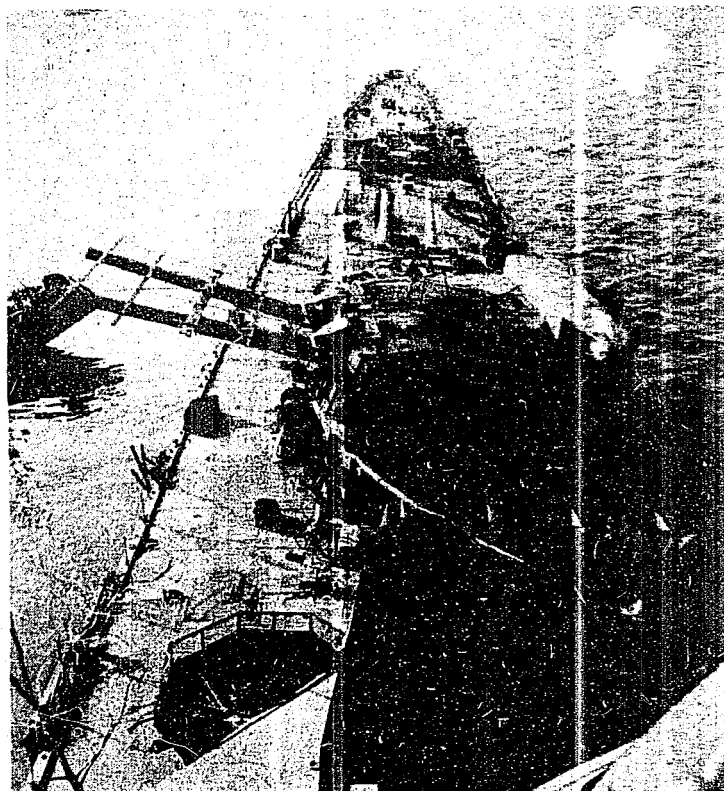
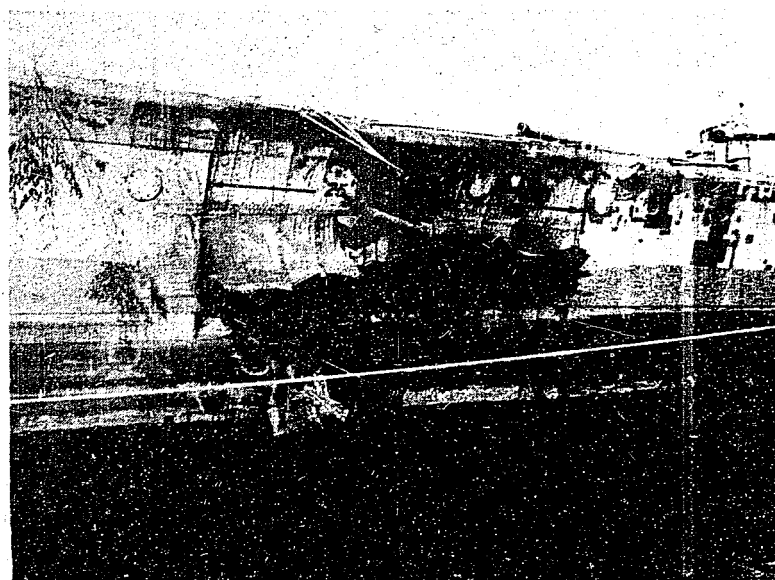
Figure 25
Hole in port shell at bow caused by Bomb No. 1.

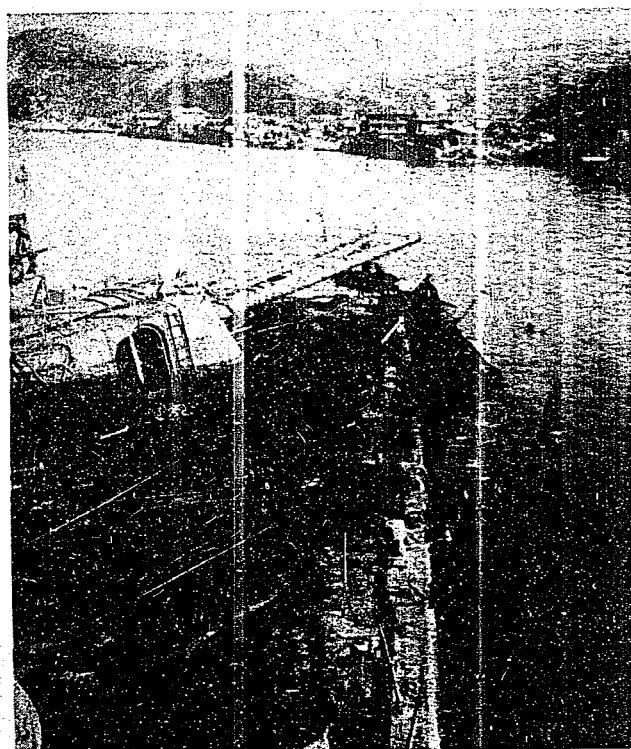
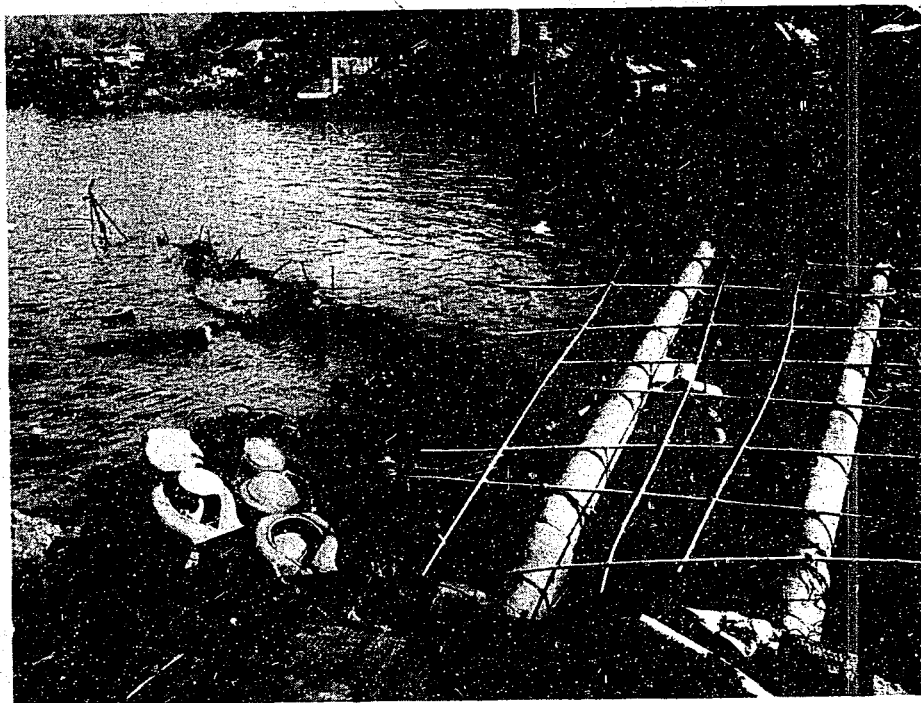
*Figure 29
Looking aft at sunken after-portion of vessel.*

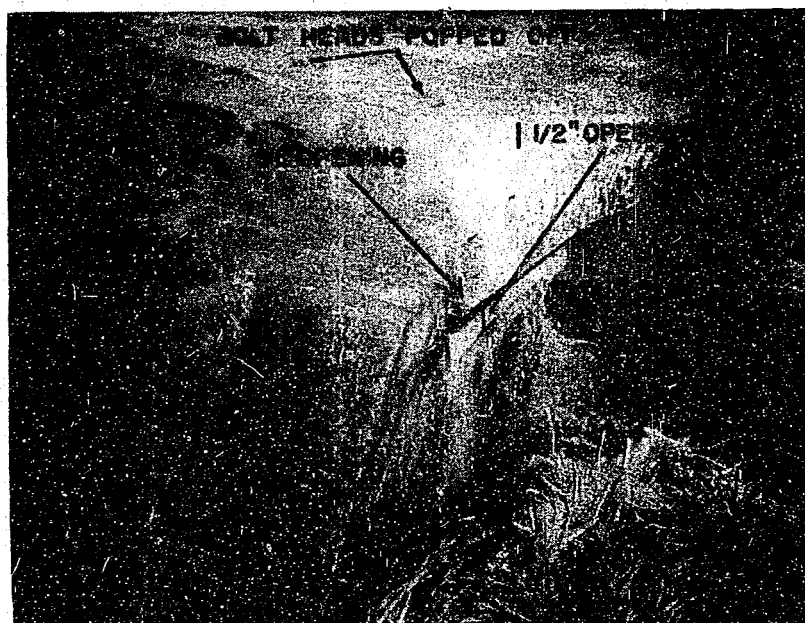
Figure 34

Turret No. 3 - opening at scarfed joint
left gun port, between 6" roof plate and
12" face plate, caused by Bomb No. 10.
(See Figure 33.)

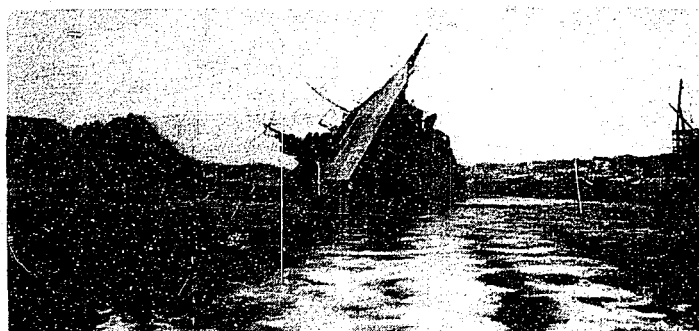
Figure 39
Capsized on 24 July.

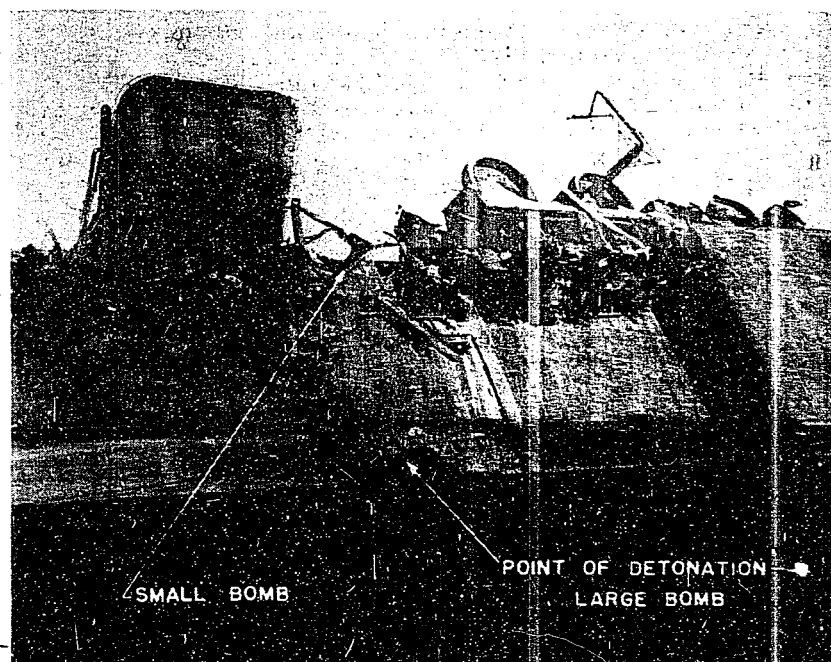
Figure 41

Damaged flight deck fallen off; upper hangar deck shown.

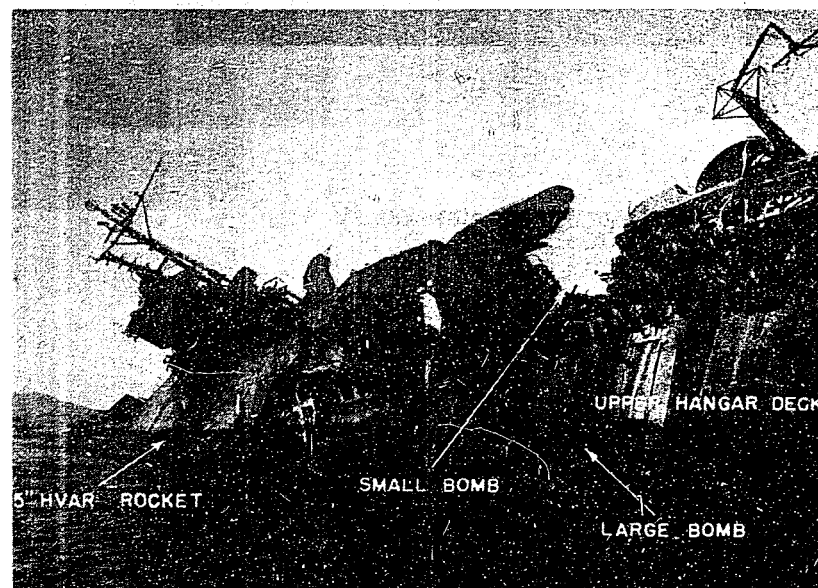
Figure 42

Looking forward along damaged flight deck and upper hangar deck.

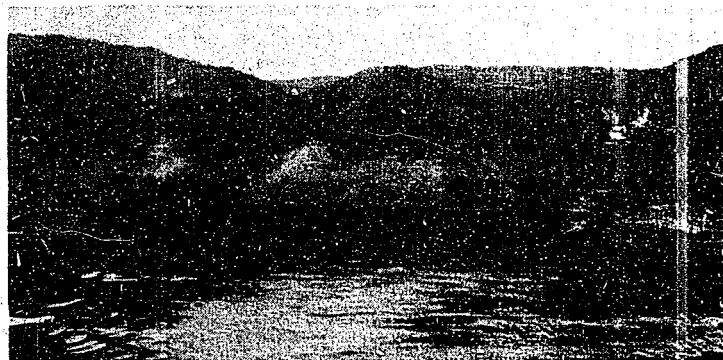
Figure 43

At anchor. Non-operational, although manned. Damaged 19 March 1945 with three bomb hits and two rockets hits.

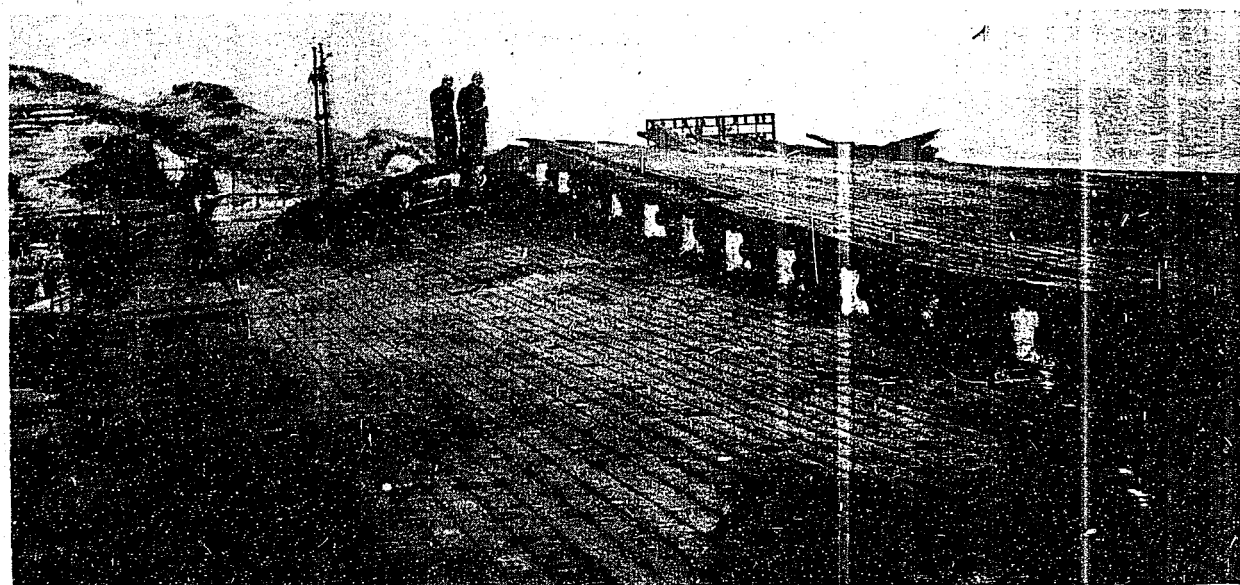
Figure 45
Damage to flight deck by Bomb No. 2.

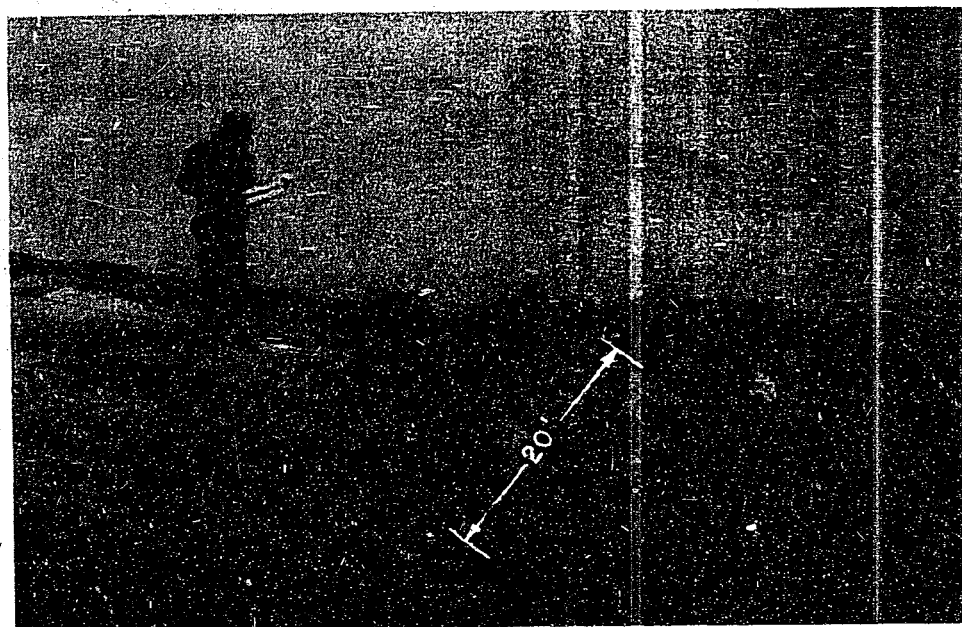
Figure 52

Indentation in port bilge plate caused by far near-miss bomb on 24 July. Most serious indentation covered length of about 20 feet. Maximum deflection was 18".

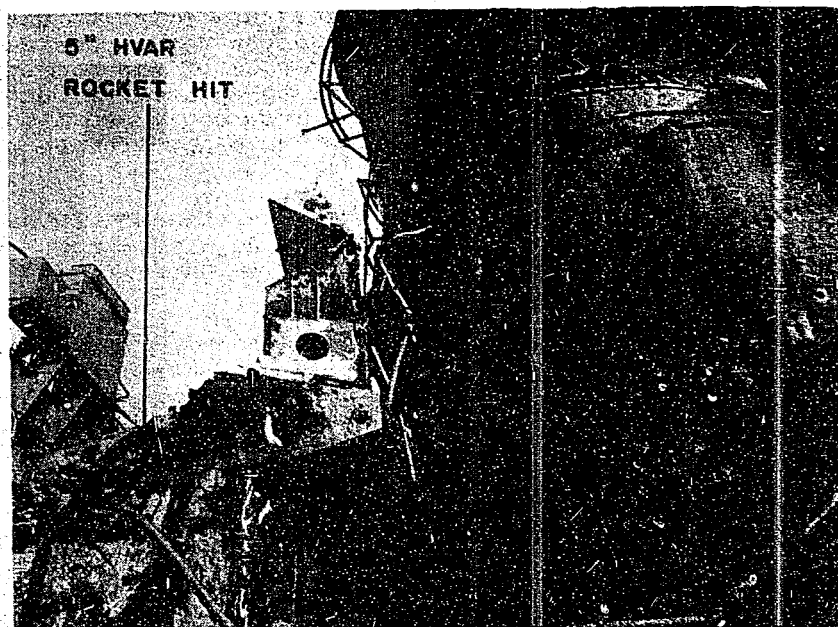
Figure 55
Hit, reported by Japanese as a rocket. Small damage identifies it as probably 5" HVAR rocket.

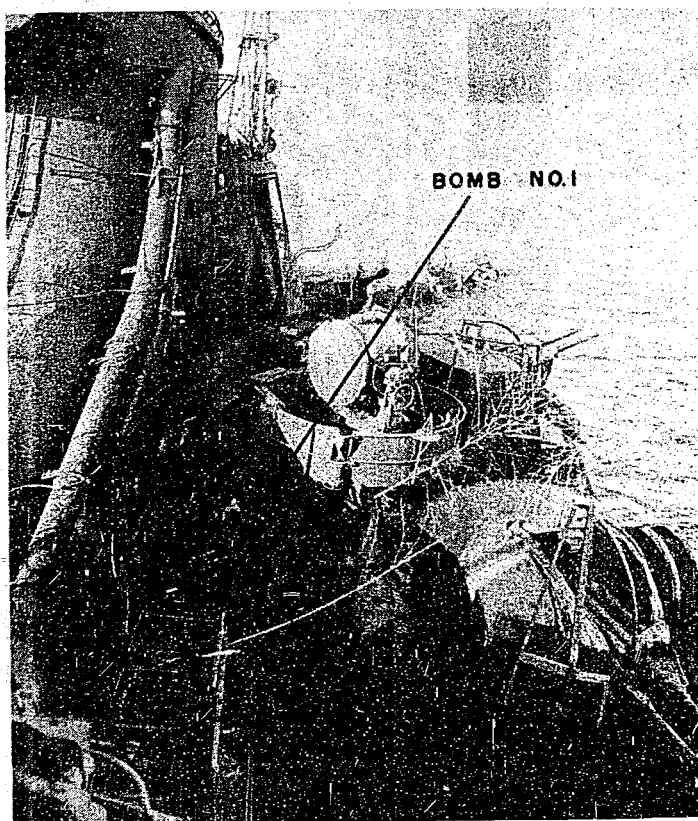
Figure 56
Path of Bomb No. 1

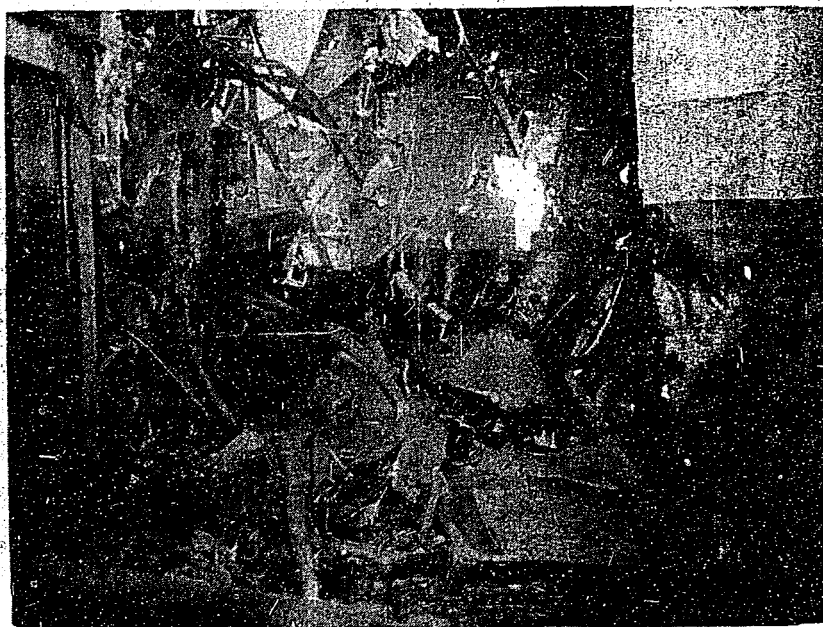
Figure 57
Close-up of damage to base of smokepipe
caused by Bomb No. 1. Looking to starboard.

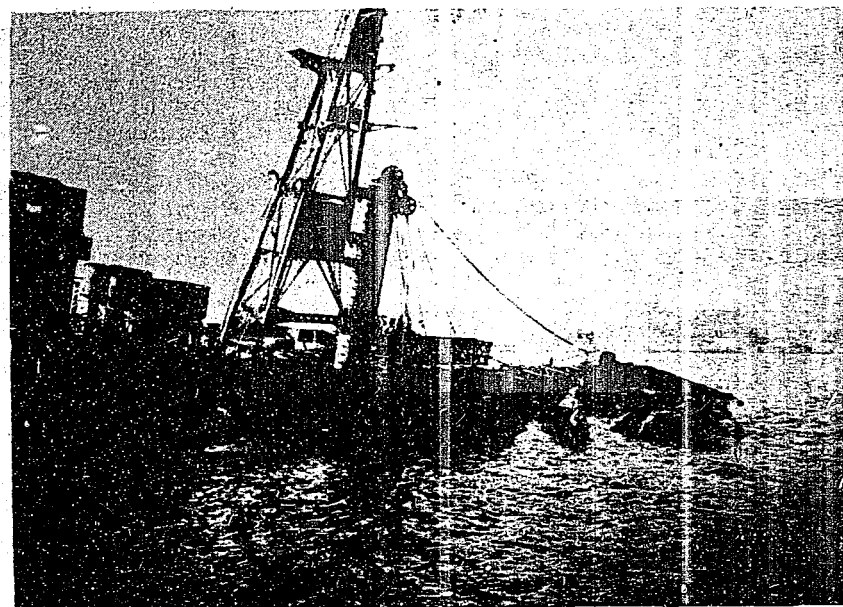
Figure 58
Large bomb, at least 1000-pound SAP, fuze
0.01 second delay, struck deck and pene-
trated below second deck, where it detonated.

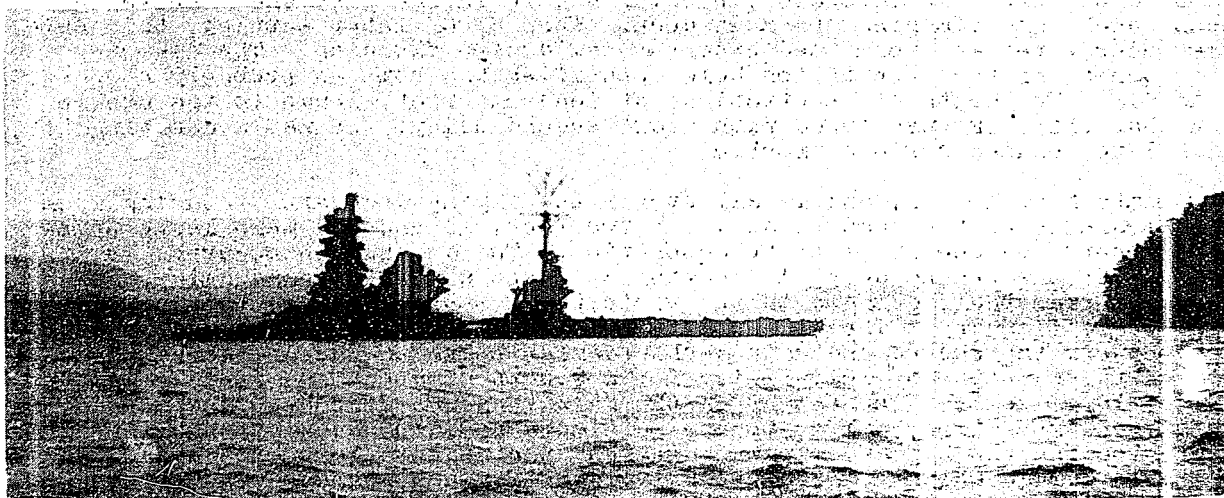
Figure 59

Sunk 24 July, but additional damage inflicted 28 July.

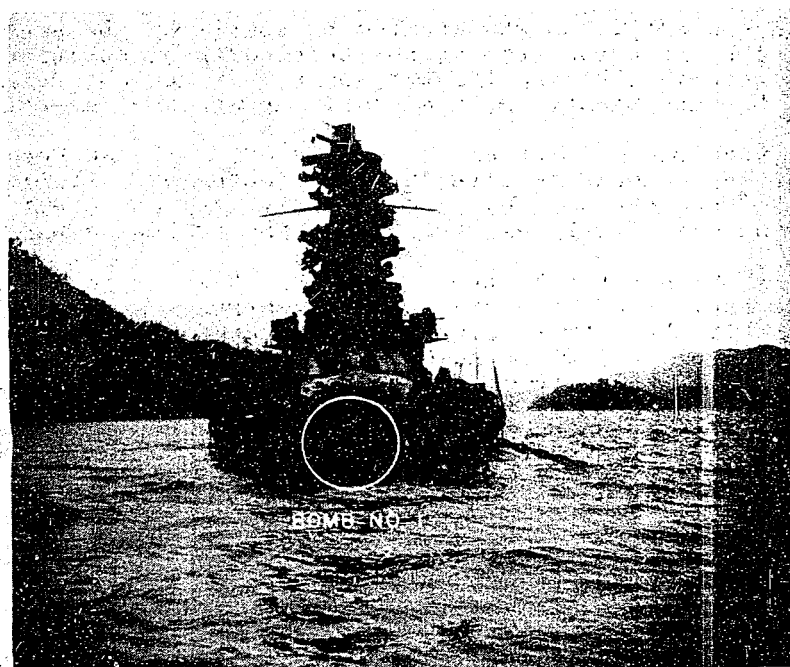
Figure 60

Bomb No. 1 instantaneously fused, blew off eyes of ship 24 July. Could have been either of two types of GP bombs dropped that day; viz., 500 or 1000 pounds.

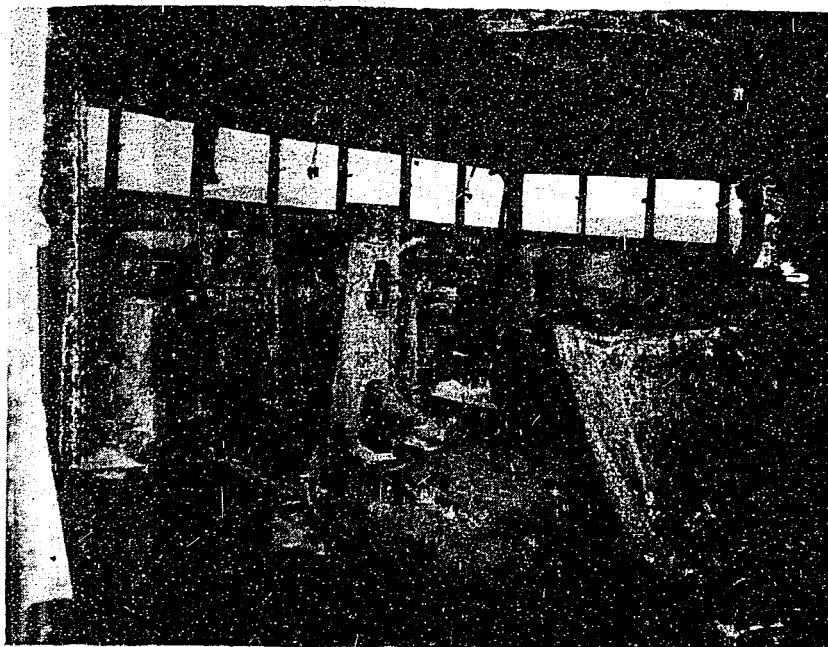
Figure 64
Looking forward on port upper deck at remains of twin 5-inch mount destroyed
by Bomb No. 8. Judging from damage, appears to have been 500-pound GP bomb,
instantaneously fused.

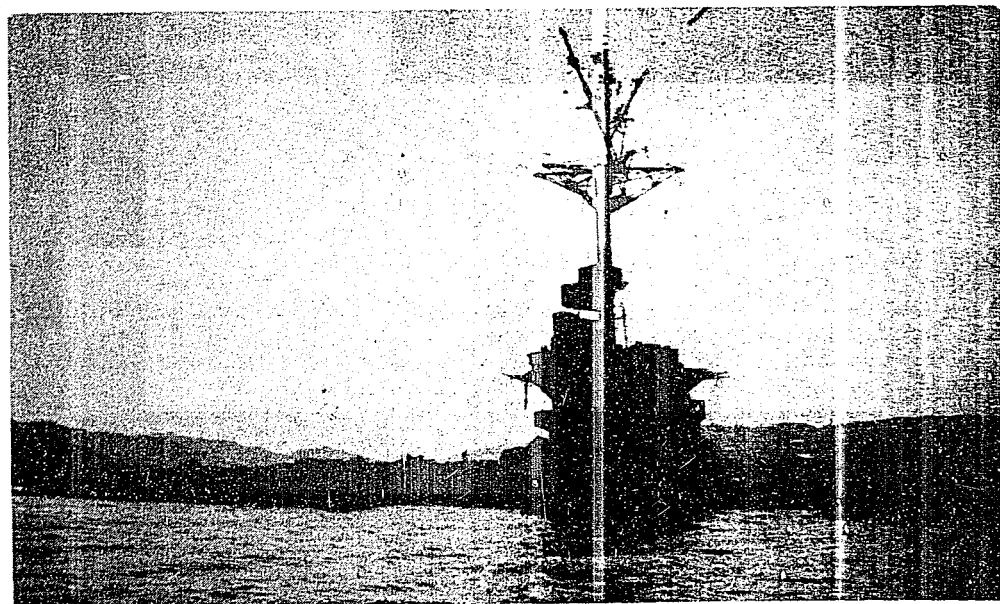
Figure 65
Looking at starboard quarter showing remains of flying deck.

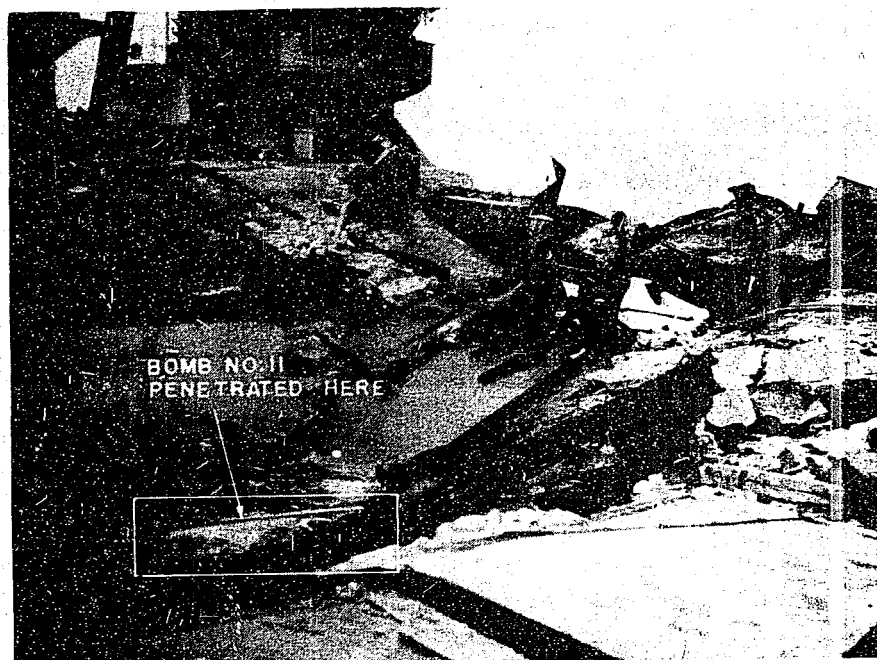
Figure 66
Looking forward on port side of flying deck. This bomb was at least 1000-pound GP, 0.025 second delay fuze. Detonated well below flying deck, destroying supports for latter and permitting general collapse. Note remnants of 8" thick concrete deck covering.

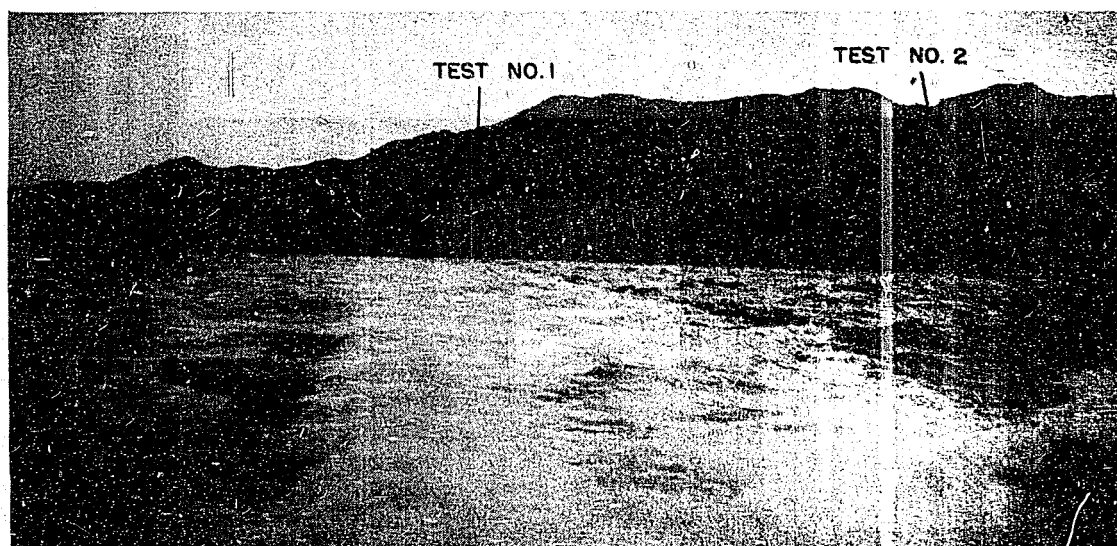
Figure 67

9. Blast damage to the extreme end of the deck was considerable, the after 40 feet being completely blown off (Figure 67). From Plate XI it will be noted that the after end of the hangar deck is only a platform, supported by girders, so this result was not surprising. A few fragments penetrated completely through the hull, emerging from the bottom. Three after compartments in the extreme stern were flooded through these holes. The Japanese again were disappointed in the results. They attributed the comparatively small amount of damage to the lack of confinement of the detonation - it being, in effect, an air detonation 15 feet above the deck.

Sunk during early part of October. Completed only to deck of upper hangar. Typhoon was final cause of loss.

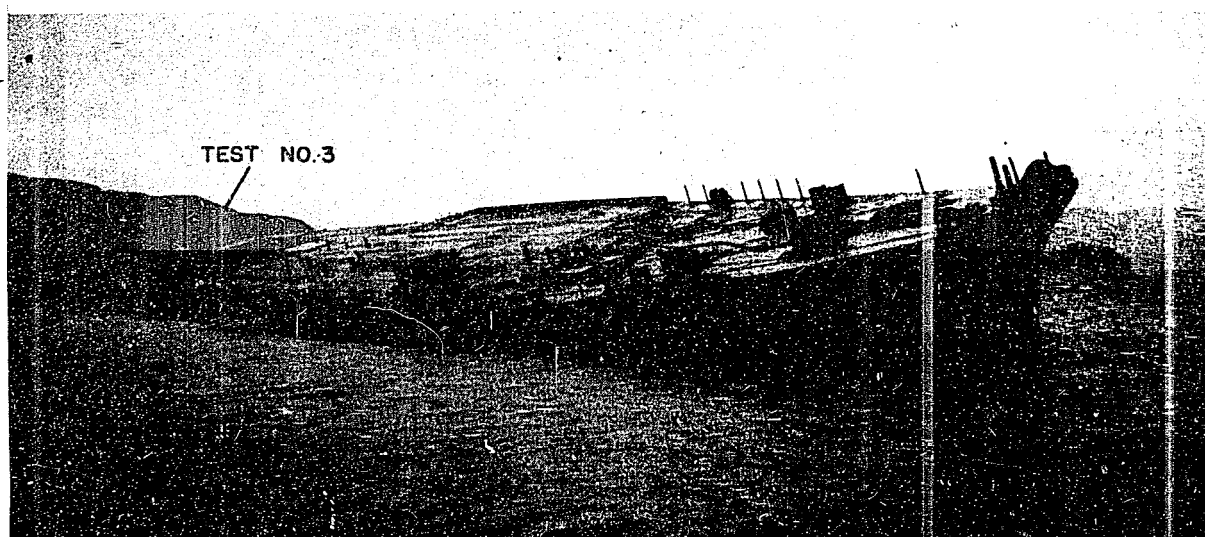
Figure 68

Note deflection of main deck from Test No. 3, a 250 kg GP bomb detonated on the lower hangar deck.
