REPORTS OF DAMAGE TO JAPANESE
WARSHIPS - ARTICLE I

NAGATO(BB), KATSURAGI(CV), HARUNA(BB), AOBA(CA)
ISE(BB), AMAGI(CV), RYUHO(CVL), OYODO(CL)
TONE(CA), HYUGA(BB), ASO(CV), SUZUTSUKI(DD)

U.S. NAVAL TECHNICAL MISSION TO JAPAN

23 December 1945

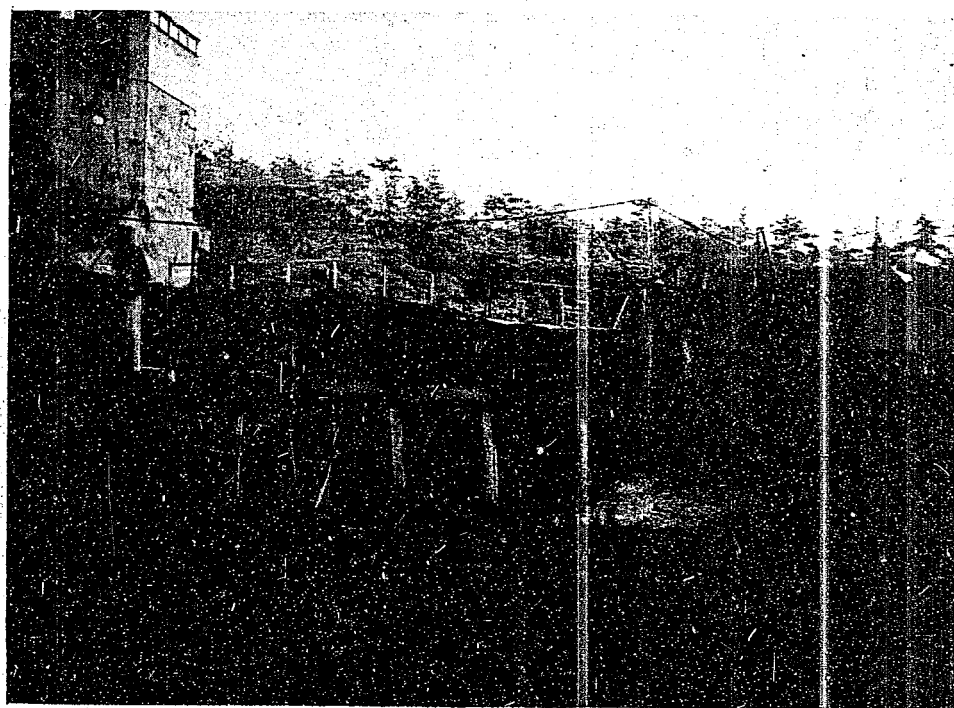
*Figure 71
Damage to port bow. No. 1 and No. 2 mounts have been removed.*

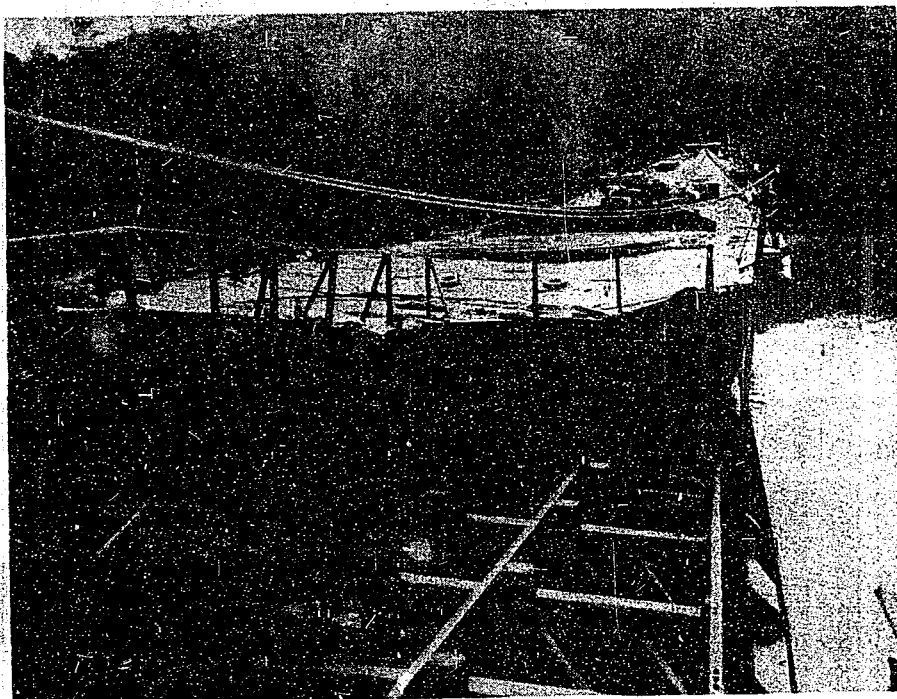
Figure 72
Looking forward. Note method of temporary bracing.

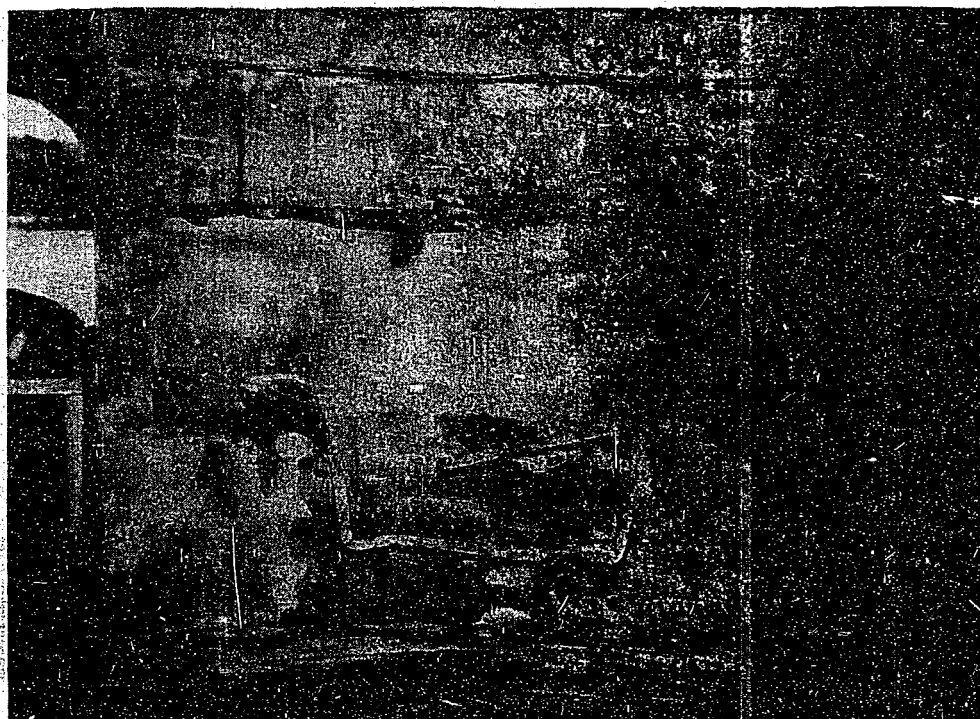
Figure 74

Looking aft at fragment holes in circular bulkhead foundation for No. 1 mount. Presumably caused by low order detonation of 3" projectiles knocked to deck by initial shock.
