TMJ
MT
X-12

EARTHQUAKE RESISTANT CONSTRUCTION IN JAPAN

JANUARY 1946

U.S. NAVAL TECHNICAL MISSION TO JAPAN

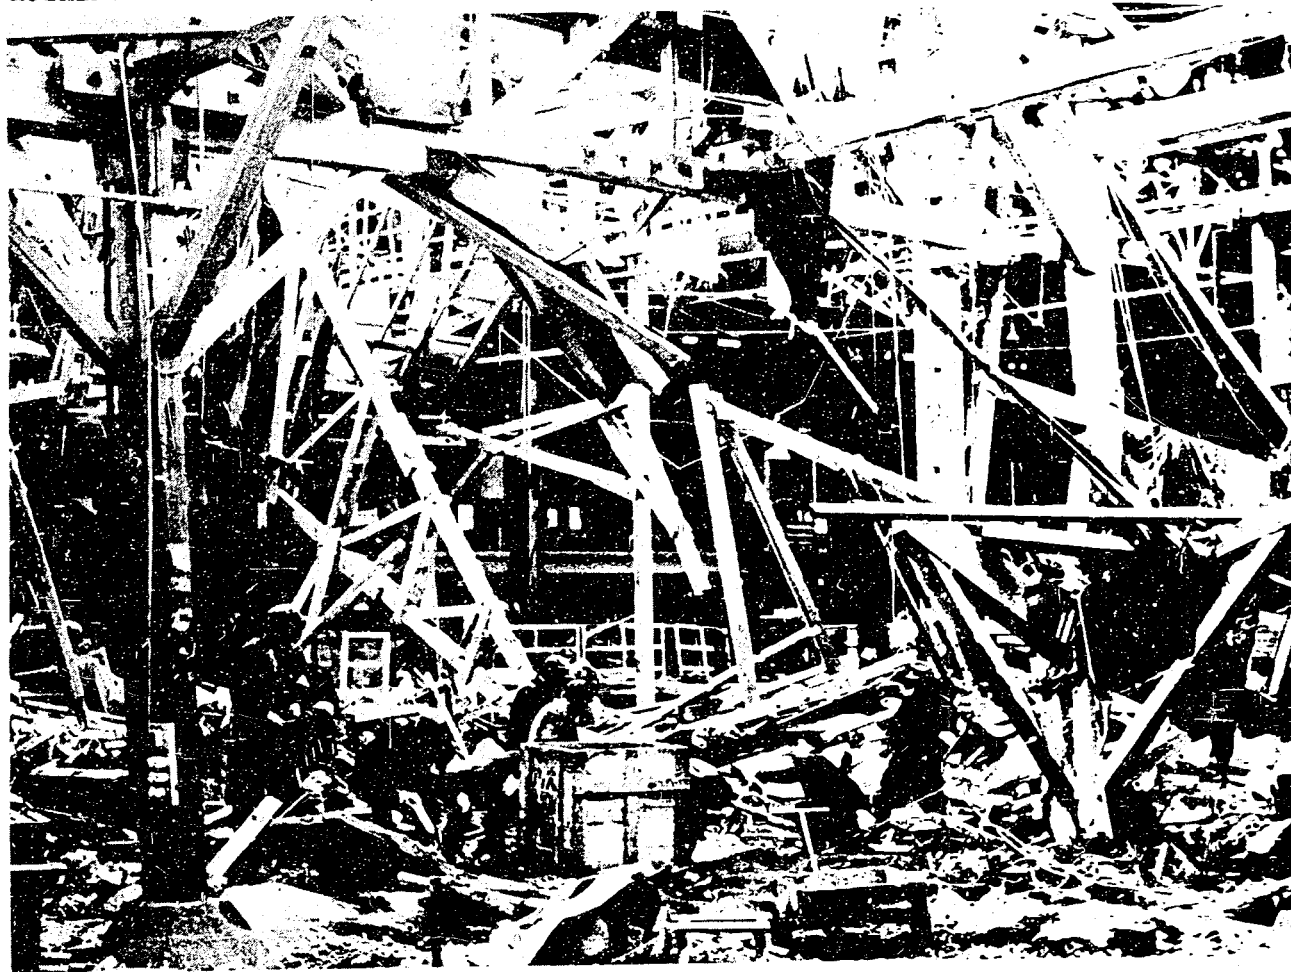
Figure 1

PARTIAL DESTRUCTION OF TIMBER-FRAME FACTORY BUILDING

*Note column head in right foreground
broken off just below brackets.*

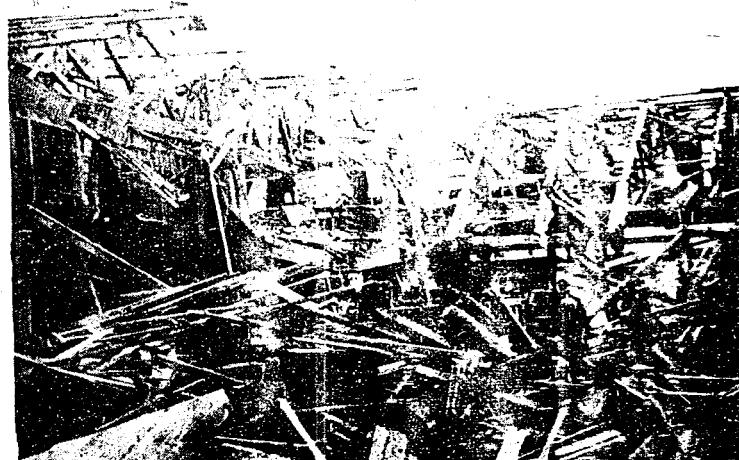
Figure 2

GENERAL DAMAGE AND PARTIAL COLLAPSE OF WARTIME TIMBER-FRAME
FACTORY BUILDING NEAR NAGOYA

Note failure of columns which allowed roof trusses to drop.

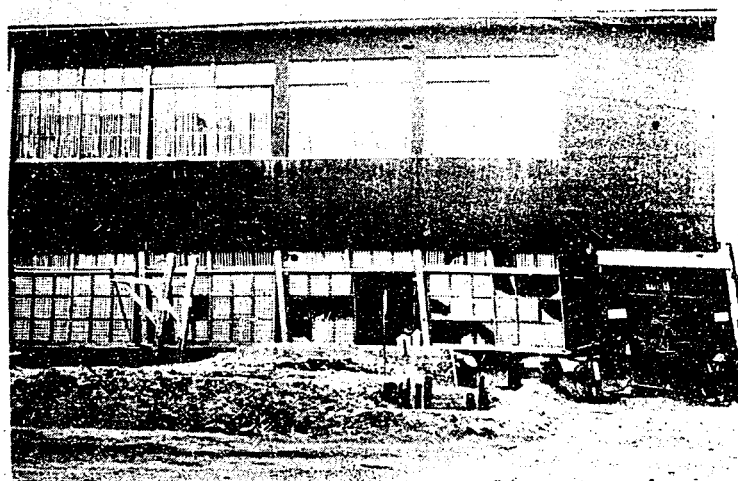
Figure 3

EXTERIOR OF TIMBER FRAME, STUCCO FINISH, FACTORY BUILDING
SHOWING HORIZONTAL DISPLACEMENT OF STRUCTURE

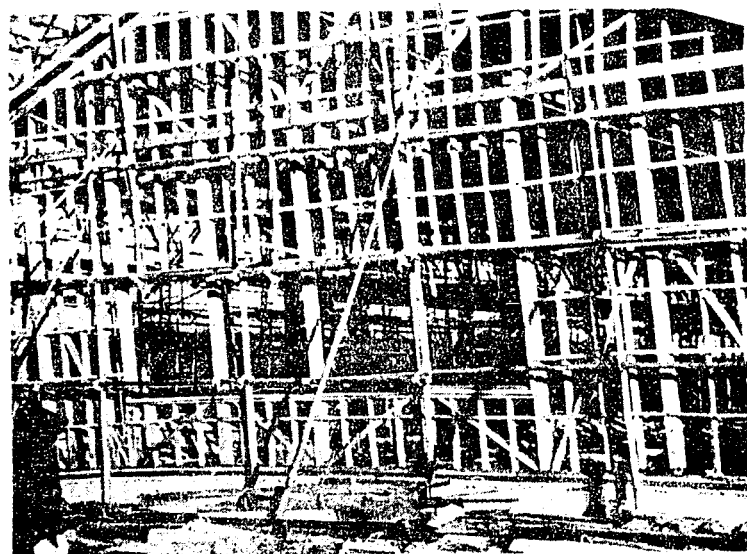
Figure 4

EXTERIOR OF END WALL OF PARTIALLY COMPLETED TIMBER STRUCTURE
AT NAGOYA SHIPBUILDING CO.

Note horizontal displacement and un-
equal settlement of foundation wall.

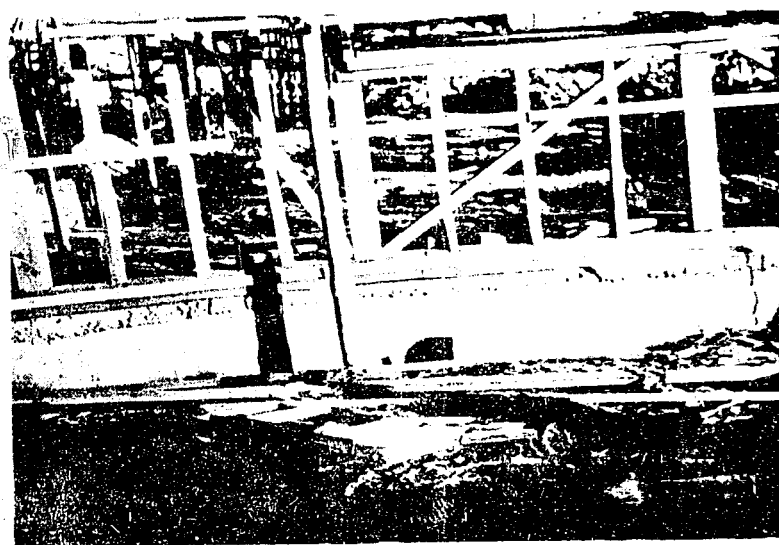
Figure 5

CLOSEUP OF FOUNDATION WALL OF STRUCTURE SHOWN IN FIGURE 4

Note large cracks in concrete re-
sulting from unequal settlement.

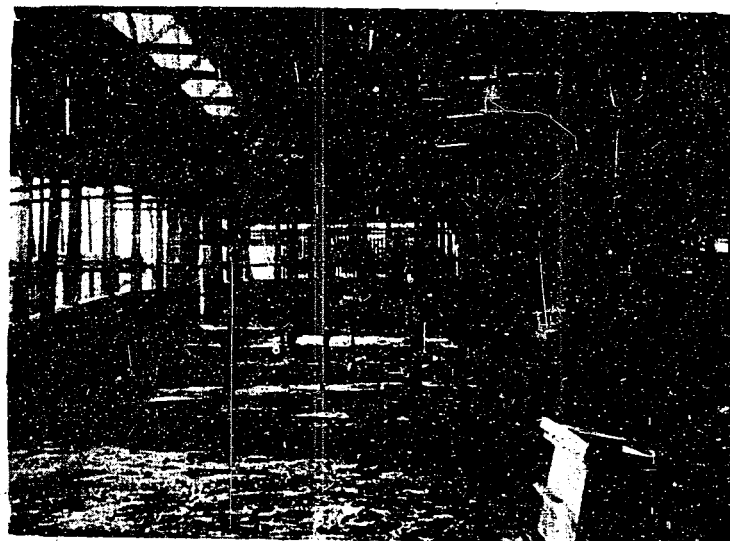
Figure 6
UNEQUAL SETTLEMENT OF FOUNDATIONS RESULTING FROM EARTHQUAKE
Note extremely light construction
of this wartime timber structure.

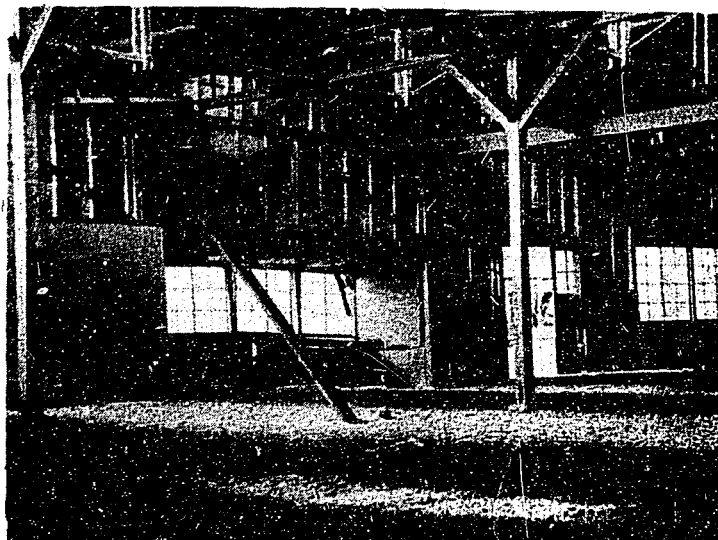
Figure 7
INTERIOR OF TIMBER STRUCTURE SHOWING UNEQUAL SETTLEMENT
OF FOUNDATION UNDER END WALL OF BUILDING
Note detail of brackets at column head.
See next photo for closeup of damage to
concrete slabs in center background.

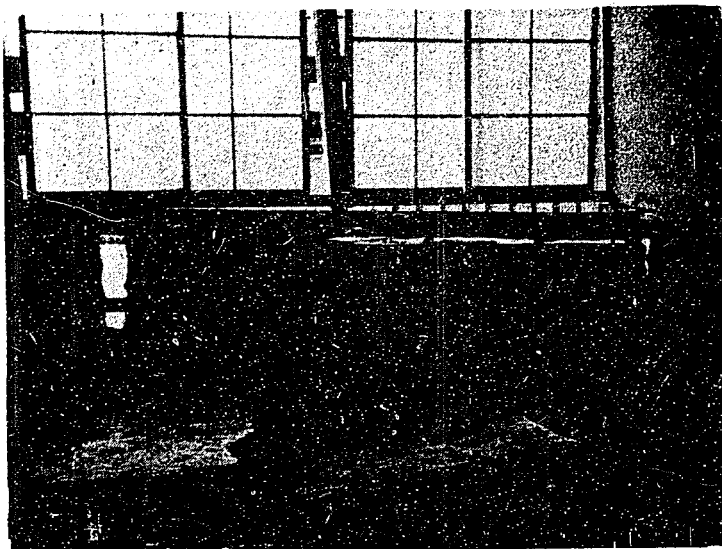
Figure 8

CLOSE-UP OF DAMAGE TO CONCRETE SLABS SHOWN IN
CENTER BACKGROUND, FIGURE 7

Note extreme vertical displacement of floor slab
and settlement of end wall foundation. Note al-
so absence of reinforcing steel in slab and
trough as well as in end wall itself.

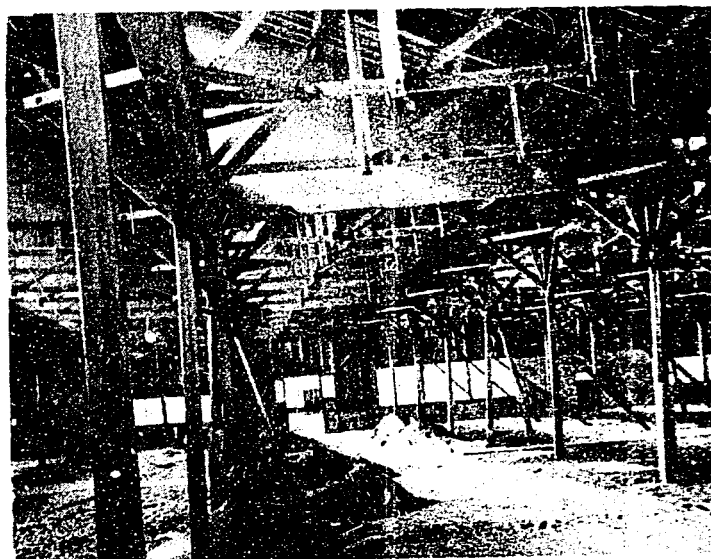
Figure 9

LINE OF COLUMNS AT LEFT ON NEWLY RECLAIMED LAND,
COLUMNS AT RIGHT ON PREVIOUSLY RECLAIMED LAND

Note comparative settlement resulting from
earthquake. Aichi Clock and Electric

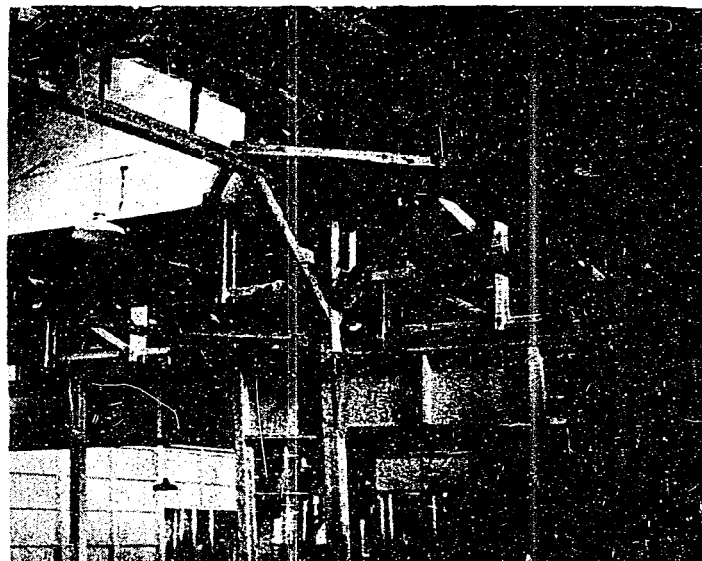
Figure 10

*SPLITTING OF HEAD OF BRACKETED COLUMN RESULTING FROM
HORIZONTAL DISPLACEMENT OF STRUCTURE*

*Steel dowel pin connection between column head and
cap. No transverse bracing except brackets at col-
umn heads and light partitions without diagonal
members. Aichi Clock and Electric Co., Nagoya.*

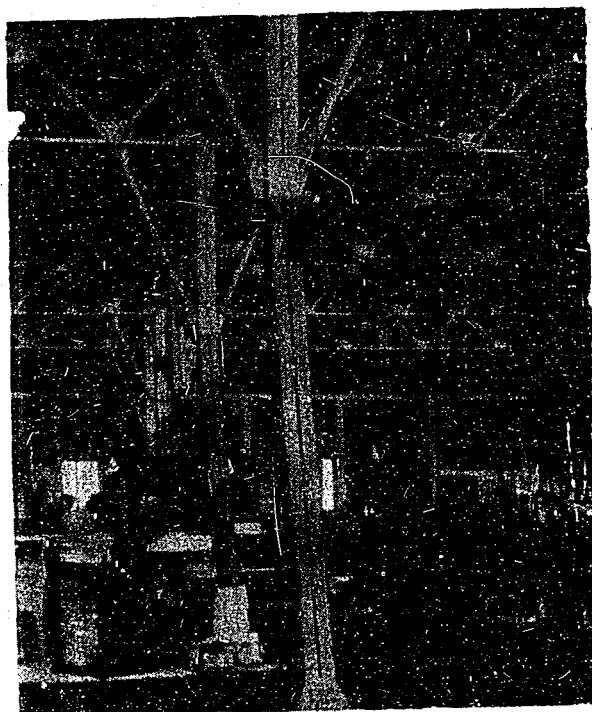
Figure 12
DAMAGE TO STEEL FRAME STRUCTURE RESULTING FROM
HORIZONTAL DISPLACEMENT OF COLUMN FOOTINGS
Aichi Aviation Co.

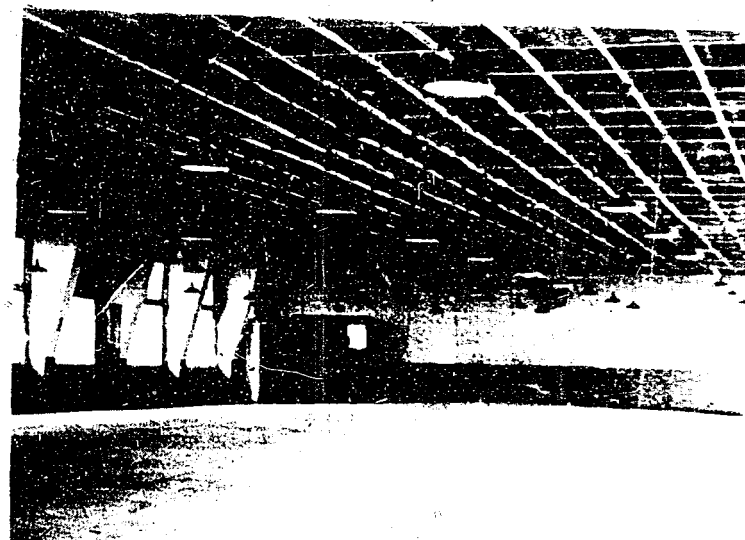
Figure 14
BULGING OF CONCRETE FLOOR SLAB

Prof. FUTAMI stated this was caused by actual upheaval of the earth and not by settlement of the wall foundations as no evidence of settlement could be observed.

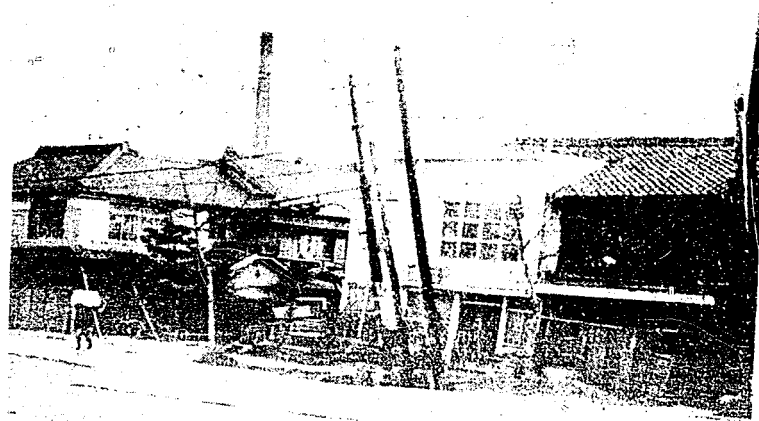
Figure 15
SETTLEMENT OF STREET CAUSED BY ITS SUBSIDENCE
ALONG VERTICAL FAULT

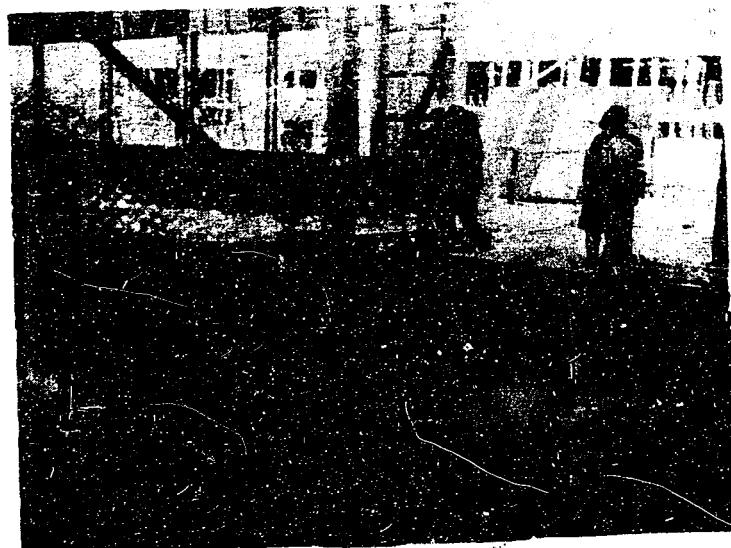
Figure 16
SETTLEMENT OF COLUMN FOOTING
Soil unable to resist punching action of footing.

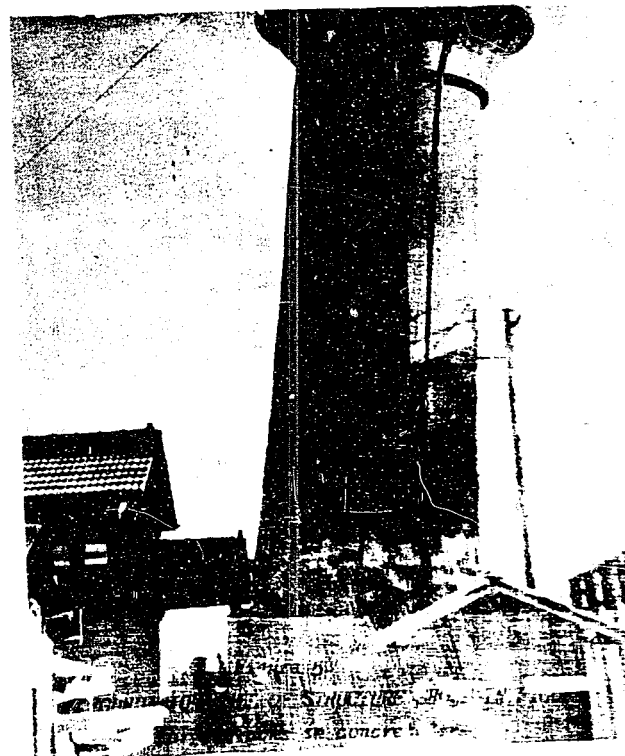
Figure 17
ELEVATED WATER TANK OF REINFORCED CONCRETE SHOWING
INCLINED POSITION RESULTING FROM EARTHQUAKE
Note major crack at about $1/3$ of height.
See following photo for close-up view.
Orido Steel Works.

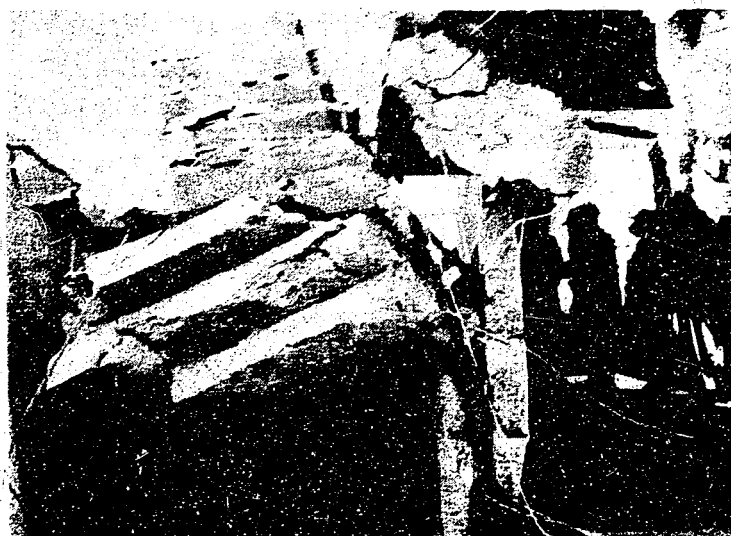
Figure 19
COLLAPSE OF CONCRETE WALLS AND STAIRWAY

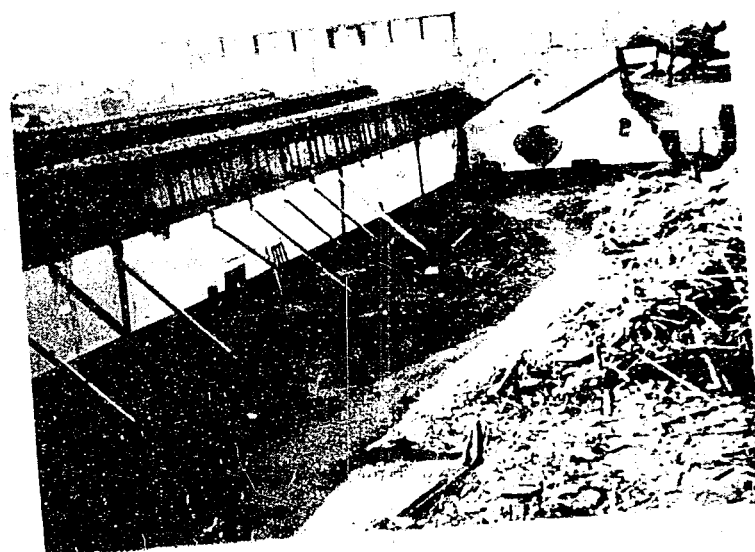
Figure 21
DAMAGE TO MASONRY STRUCTURE
WHICH BRASS-ROCK CONNECTION COMPLETELY
LAPSED. MASONRY BUILT SUFFICIENTLY DAMAGED
TO REQUIRE REPAIRS.

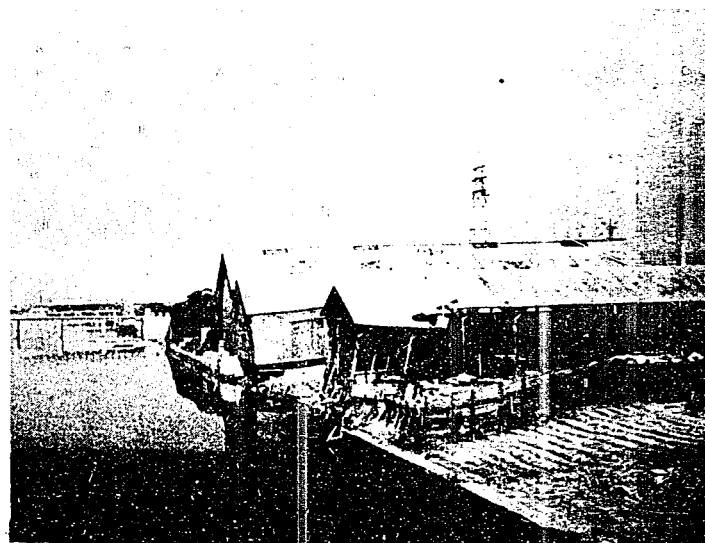
Figure 22

RESULT OF FAILURE OF MASONRY RETAINING WALL
Column footings of two end bents slipped toward canal

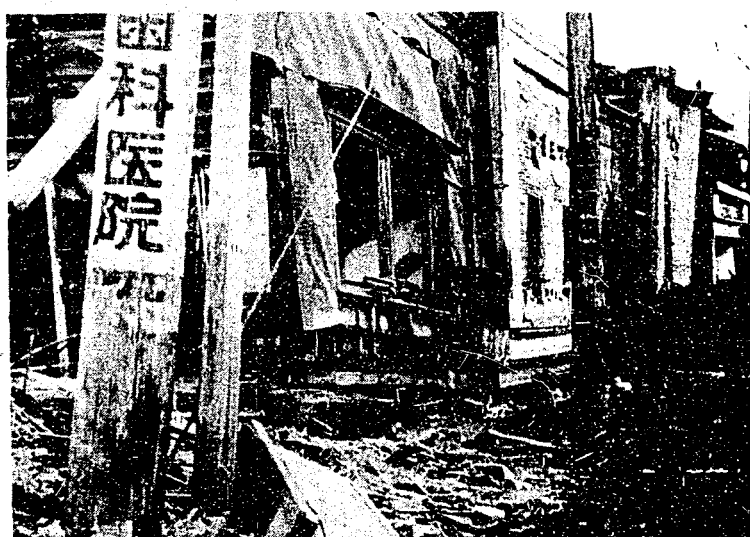
Figure 23

RESULTS OF COMPLETE COLLAPSE OF THE FIRST STORY OF A TYPICAL
TWO-STORY COMBINATION STORE AND DWELLING

Structure in foreground is second
story of original two-story building.

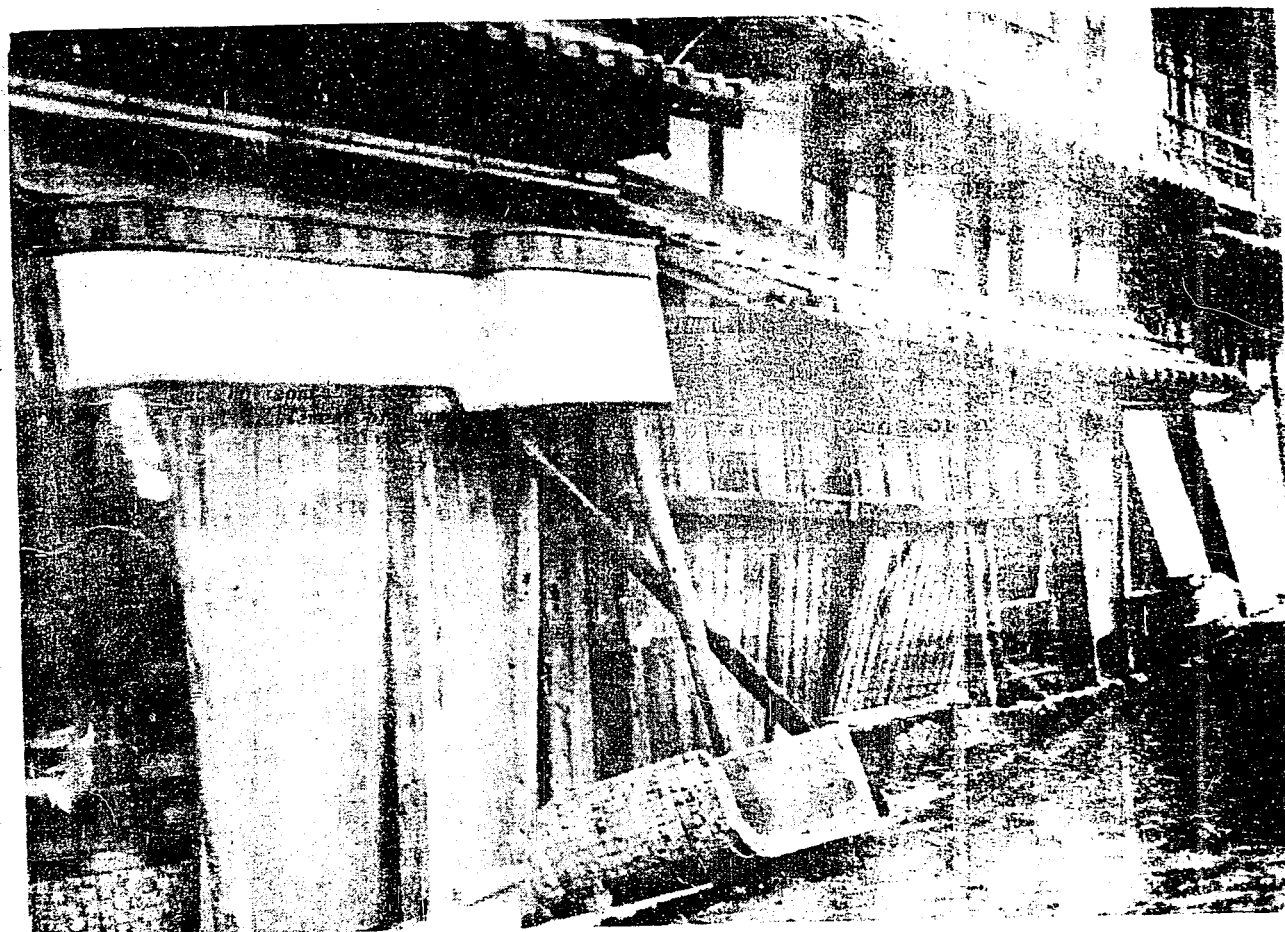
Figure 24
PARTIAL COLLAPSE OF TYPICAL WOOD-FRAME DWELLINGS
