SECTION II

Operations & Economics

5.0 TECHNICAL PERFORMANCE

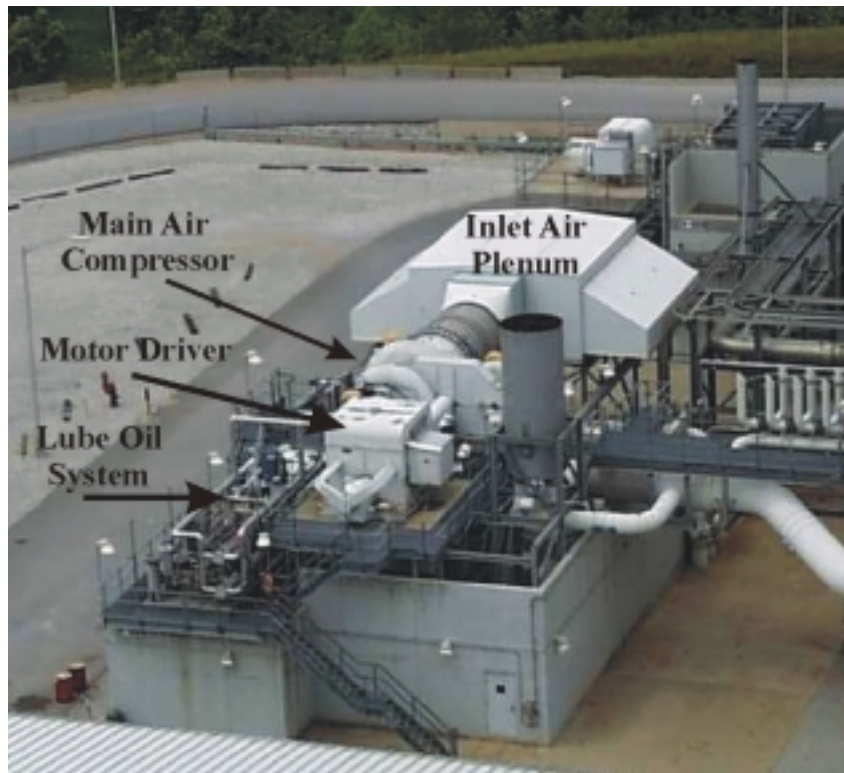
Figure 5.1.1A: Main Air Compressor

The inlet guide vane subsystem was recognized very early in system operation as the biggest reliability issue for the main air compressor. Specifically, guide vane corrosion as a result of moisture, infrequent guide vane movement, and inadequate weatherproofing of the guide vane actuators and their controllers were all noted as concerns resulting from improper design. Fifty-three hours of downtime were suffered beginning on January 25, 1998 due to the inlet guide vane subsystem. In addition to this specific downtime incident, maintenance performed on the guide vane subsystem was frequent and costly. On one occasion prior to the Operating Period, one of the three guide vanes required complete extraction from the compressor in order to allow repair to a twisted actuator shaft suffered while attempting to stroke the guide vanes after a prolonged period of inactivity.

Failure of the main air compressor's discharge vent valves caused 35 hours of downtime beginning on January 11, 1998. These valves provide surge protection for the main air compressor and are normally held in their fully closed position while the machine is running. These surge valves are subjected to extended time periods without being exercised, and therefore, are susceptible to corrosion that causes them to be stiff and difficult to operate. The experienced downtime as a result of their non-responsiveness prior to the Operating Period prompted the implementation of a preventative maintenance plan. The plan includes lubrication of the valve actuators and periodic stroking of the valves through their full range of motion during outages.

A routine inspection of the main air compressor's motor driver prior to the Operating Period showed evidence of moisture within the motor enclosure. The moisture was visible in the bottom of the enclosure as well as detected in the insulation of the motor windings through standard electrical testing. Although it did not lead to downtime, moisture within the windings of such a large, high-voltage motor was addressed with top priority due to its potential to cause a catastrophic failure of the windings. It was determined that the fiberglass motor enclosure was inappropriately designed for outdoor service. Hairline cracks and pinholes around the rivet points and seams in the enclosure provided possible entrance points for moisture. As an immediate action, care was taken to seal the enclosure by application of a commercially available sealant. Further investigation of the system revealed that the electric heaters within the motor enclosure were improperly installed during construction and had never functioned. The installation error was rectified, and the heaters began functioning as designed. As an added precaution, a procedural change was made to include removal of the cooling water flow from the motor immediately after a shutdown of the machine. Cooling water flow significantly counteracted the positive effects of the motor enclosure heaters, and may have promoted moisture condensation during the winding cooldown period immediately following the shutdown of the main air compressor.

Actuators have been highly susceptible to weather conditions, the electronic controllers for the actuators have proved to be imprecise and difficult to manage, critical components have worn

quickly and repeatedly and replacement parts that should be commonplace have been difficult to procure. Furthermore, all of these difficulties have been compounded by the fact that the original equipment manufacturers for both the compressor and guide vane actuators have not been cooperative with regard to corrective actions. Future gasification projects requiring the installation of air compressors of this magnitude need to pay particularly close attention to the detailed design of the main air compressor's inlet guide vane subsystem.

The actuators on the inlet guide vane subsystem for the main air compressor were replaced in October 1999, with a new third party design (Figure 5.1.1B). Some of the benefits of the new actuators include the following. The new system is designed for all weather conditions, which should eliminate plant downtime associated with moisture. The new design completely eliminates the field electronics inherent with the old system, thus simplifying guide vane control. The new actuators are designed for more cycles of operation than the plant could reasonably require in the course of several decades. All three actuators have a mechanism to allow them to be manually positioned and locked anywhere within their full range of motion providing the capability to perform actuator maintenance while the main air compressor remains on line. The new system incorporates only parts made in the USA, thus reducing cost and delivery lead-times. All three stages now utilize identical components affording a reduction of spare inventory. The actuators have caused no downtime since installation, and are expected to eliminate the air separation unit's largest source of downtime.

While installing the new inlet guide vane project for the main air compressor, all three of the guide vanes needed to be removed from the compressor for inspection and repairs. During this process several small improvement projects were implemented in order to prevent damage to the inlet guide vanes and reduce costs of future guide vane repairs. They include the addition of lift points to the large diameter second and third stage air pipe spools to reduce rigging and lifting efforts while increasing safety and the addition of drain valves for each guide vane flange to prevent internal guide vane corrosion. Also, new flanges were added to the compressor oil return line to improve access for future guide vane extractions. Finally, proper mechanical design was implemented via materials selection for the guide vane shaft and shaft key, providing future equipment protection.

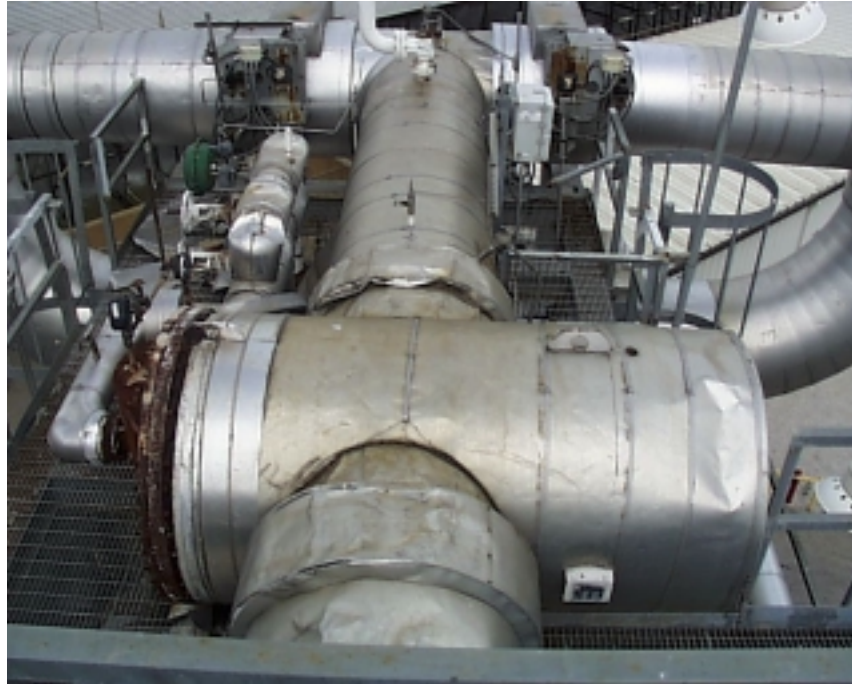
Figure 5.1.3B: Regeneration Heater for the Air Purification System

In addition to the gas distribution design remediation project, the regeneration heater required extensive and regular maintenance to repair leaking steam tubes. The regeneration gas exchanger has an external pass-partitioned collector box and the tube segments connecting the external collector box to the exchanger body are exposed to high thermal stresses and were prone to fatigue failures. Although no downtime was attributed to the regeneration heater during the Operating Period, multiple and regular tube repairs were required.

The gas distribution hardware of the regeneration heater was modified during the Operating Period to include enhanced stiffening supports to prevent collapse of the regeneration heater gas baffles. The additional support restored the proper gas contact and thus increased the efficiency of the regeneration heater, resulting in improved regeneration heat peaks on the adsorber beds. Prior to the modification, the air separation unit struggled to maintain production levels during periods of hot and humid weather as a result of increased moisture carryover to the adsorber beds. The increase in heater efficiency relieved production limitations during those times by providing more heat energy to drive off the excess moisture in the regeneration cycle. During all

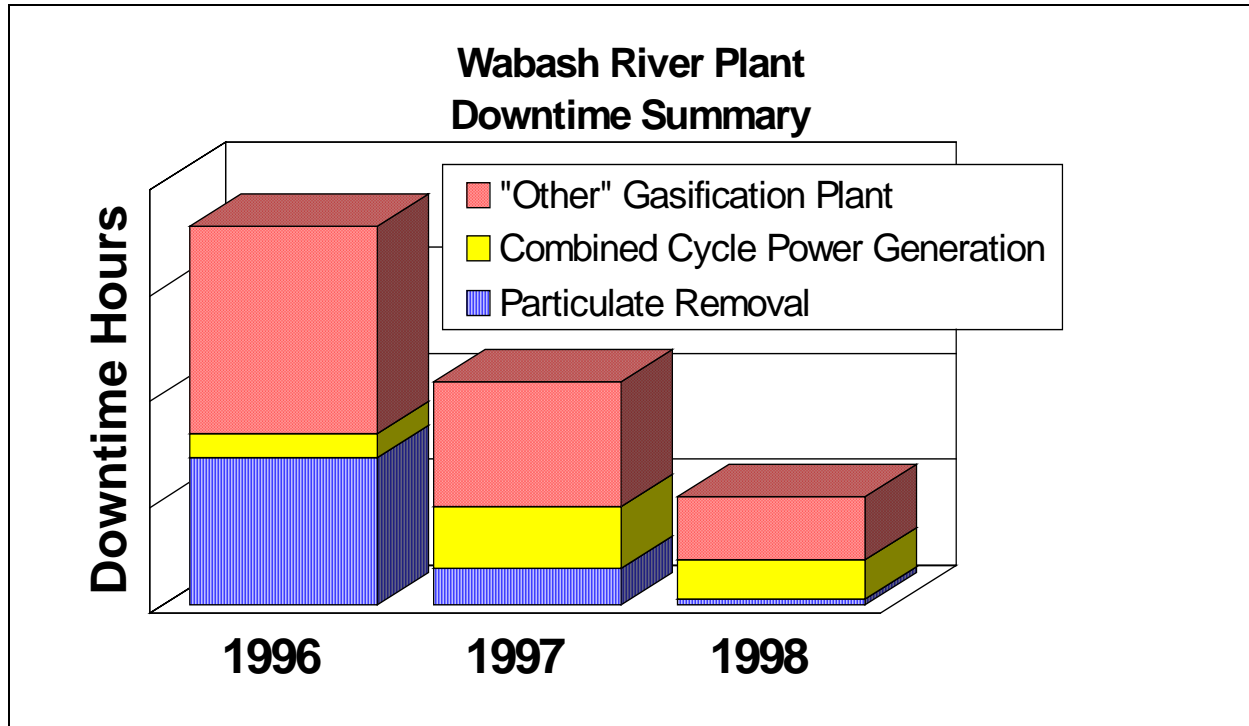
Figure 5.3.6A: Wabash River Plant Downtime Summary

Figure 5.3.6A is a chart that shows the percentage of total downtime hours attributable to the particulate removal system as well as plant outage hours caused by other gasification plant processes and the combined cycle power generation facility. In 1996, difficulties in the particulate removal system made up over 39% of the total plant downtime. As particulate removal system improvements were implemented, its operation improved in 1997 with the total attributable downtime being reduced to around 17%. Additional improvements in 1997 and

early 1998 have further reduced the particulate removal system downtime hours to less than 6% of the total.

Since plant start-up, there have been many design and materials of construction changes that have been implemented to significantly increase the reliability of the Wabash River particulate removal system. However, opportunities remain for improving the system in order to meet specific performance goals that will further reduce operating and maintenance expenditures. A number of key areas continue to be intensely studied and improved. Accelerated filter blinding continues to be a concern and is an area of keen interest in filter development work. Filter corrosion is also a concern when operating with metal candle filters, especially if higher sulfur-containing feedstocks are used. There is still a need to further improve the internal gas distribution system to extend component life and minimize filter gas impingement velocities.

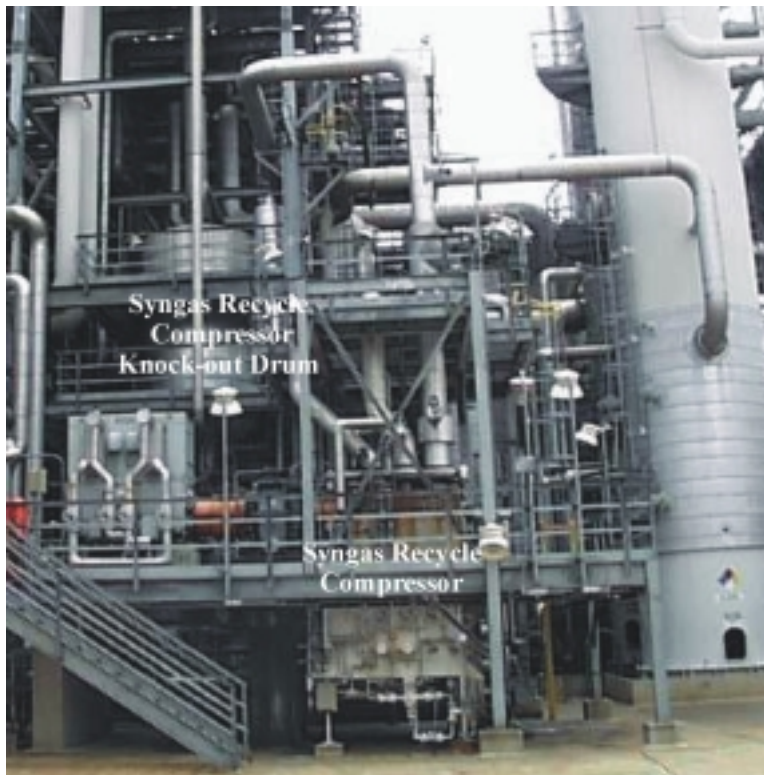
Figure 5.3.9B: Syngas Recycle Compressor and Knockout Drum

The syngas recycle compressor shutdown during methane operations on three different occasions. The compressor tripped each time on low-low first stage flow as a result of start-up conditions, which starved flow to the machine. Because the plant was not on coal operation, none of the trips resulted in downtime. Modification to the start-up procedure as well as operator awareness of the potential low flow condition has alleviated this problem. As mentioned previously, instrument problems associated with the sour gas condensate condenser and the recycle compressor knockout drum forced the syngas recycle compressor off line two times during coal operation. During the latter of these two incidents, the syngas recycle compressor failed to restart on three successive attempts due to high thrust conditions. The root cause of the high thrust could not be determined and the machine started normally on the next attempt after allowing the motor windings to cool for one hour. During a subsequent routine outage, the axial thrust proximity probe was reset in an effort to mitigate the forgoing problem. No other downtime, maintenance or operational problems were associated with the syngas recycle compressor during the Operating Period.

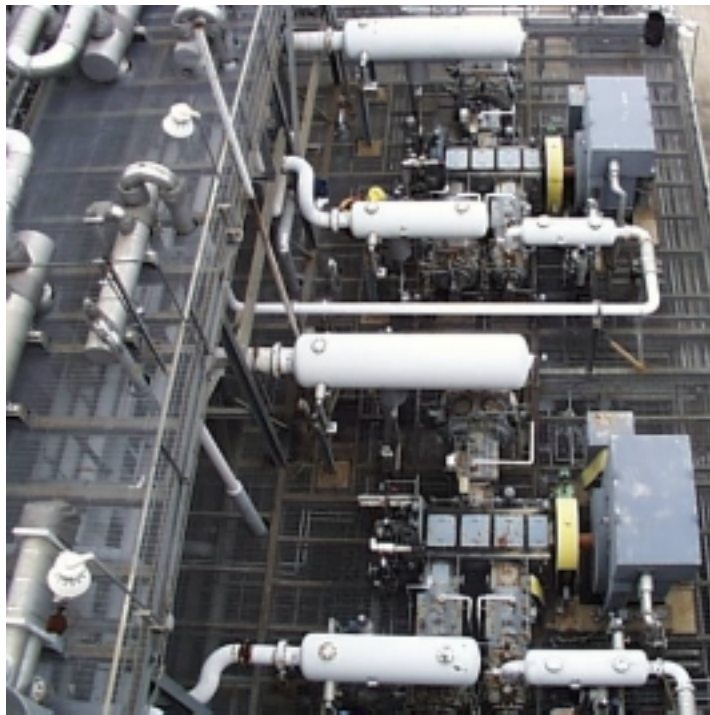
Figure 5.3.12C: Tail Gas Recycle Compressors

The tail gas recycle compressors have been a source of significant maintenance during the Operating Period. Much of the maintenance has been related to the internal check valves within the compressor. Frequent check valve failures have contributed to poor compressor reliability. However, changes in check valve design throughout the Operating Period have helped increase the reliability of the machines.

During the Operating Period, the seal leg on the first stage suction drum to the compressors was extended. Due to small suction pressure fluctuations, the seal leg would de-inventory allowing tail gas to escape to a nearby sump. The seal leg was extended to provide greater resistance to the pressure fluctuations.
