REPORTS OF DAMAGE TO JAPANESE
WARSHIPS - ARTICLE I

NAGATO(BB), KATSURAGI(CV), HARUNA(BB), AOBA(CA)
ISE(BB), AMAGI(CV), RYUHO(CVL), OYODO(CL)
TONE(CA), HYUGA(BB), ASO(CV), SUZUTSUKI(DD)

U.S. NAVAL TECHNICAL MISSION TO JAPAN

23 December 1945

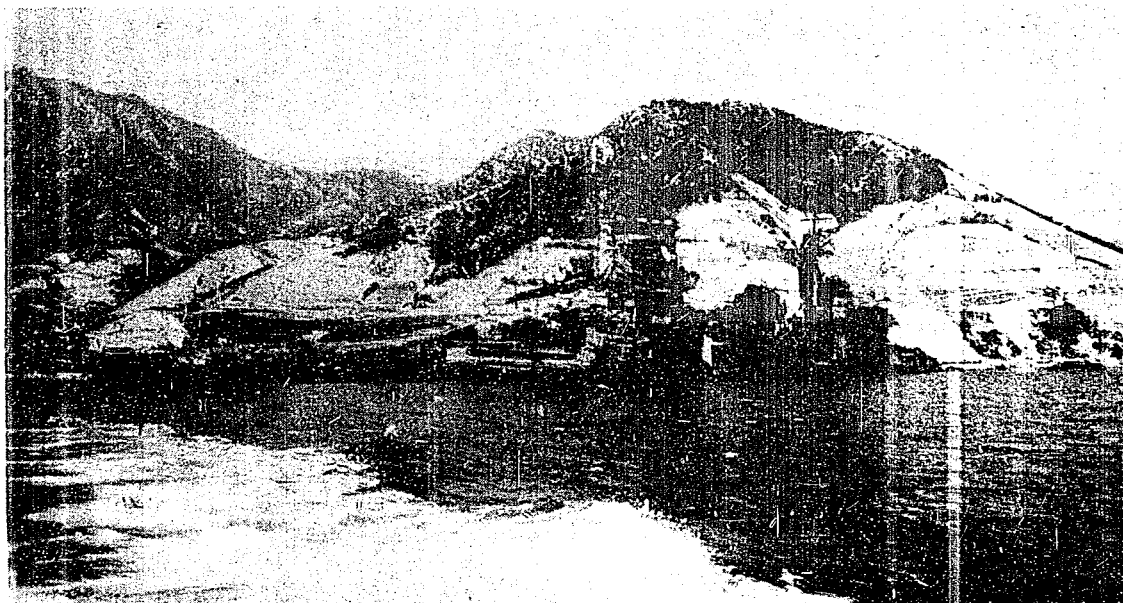
6. HARUNA was inspected on 24 November 1945. The main deck aft was submerged (Figures 15 and 16). For hits abaft No. 3 turret, it has been necessary to rely on Japanese reports. Because of the large number of hits, they have been numbered from forward to aft, starting at the bow.

*Figure 15
Looking aft along port side.*

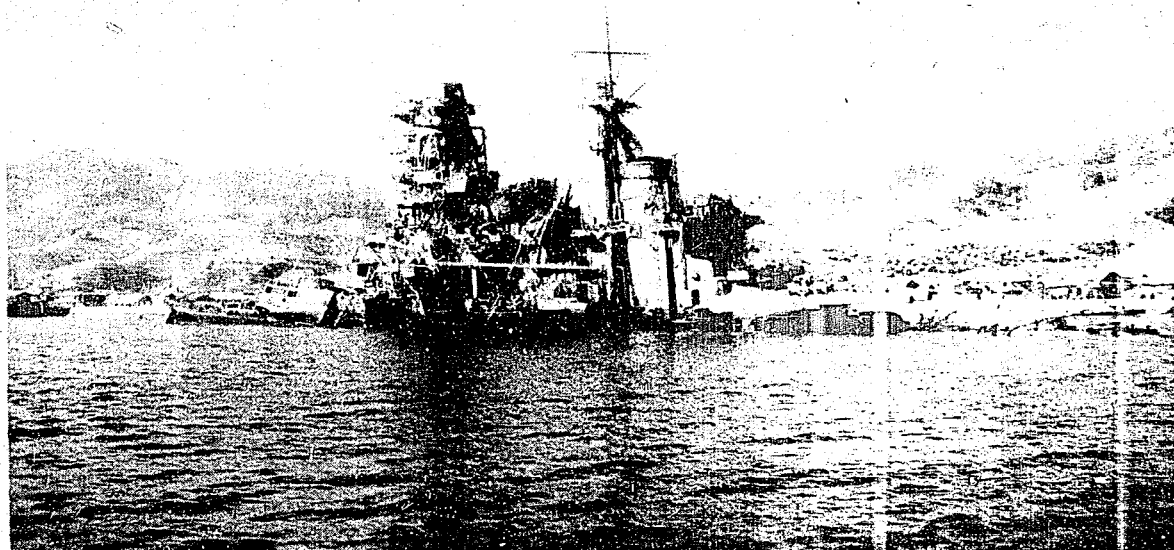
*Figure 16
Looking forward along port side.*

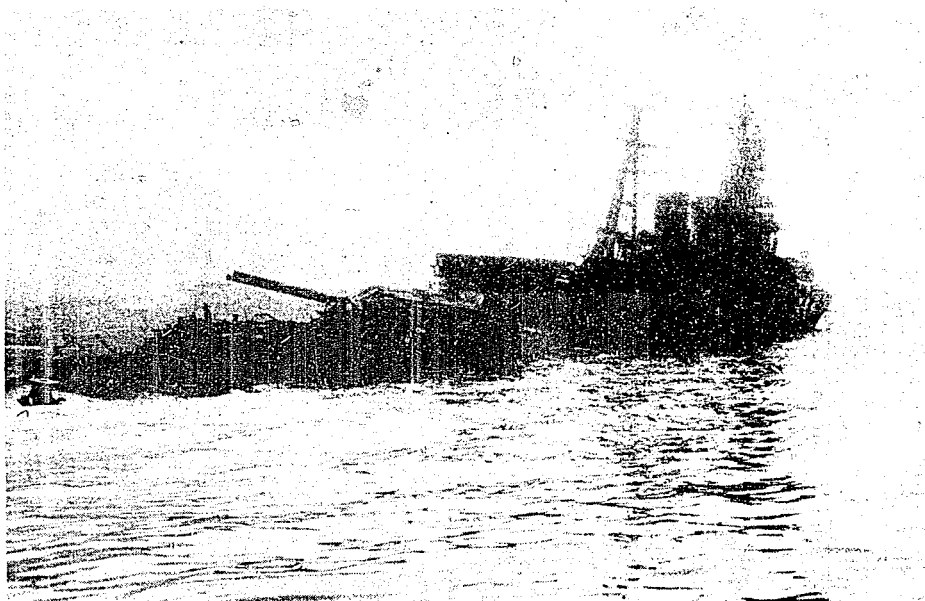
Figure 22
Looking aft from port bow.

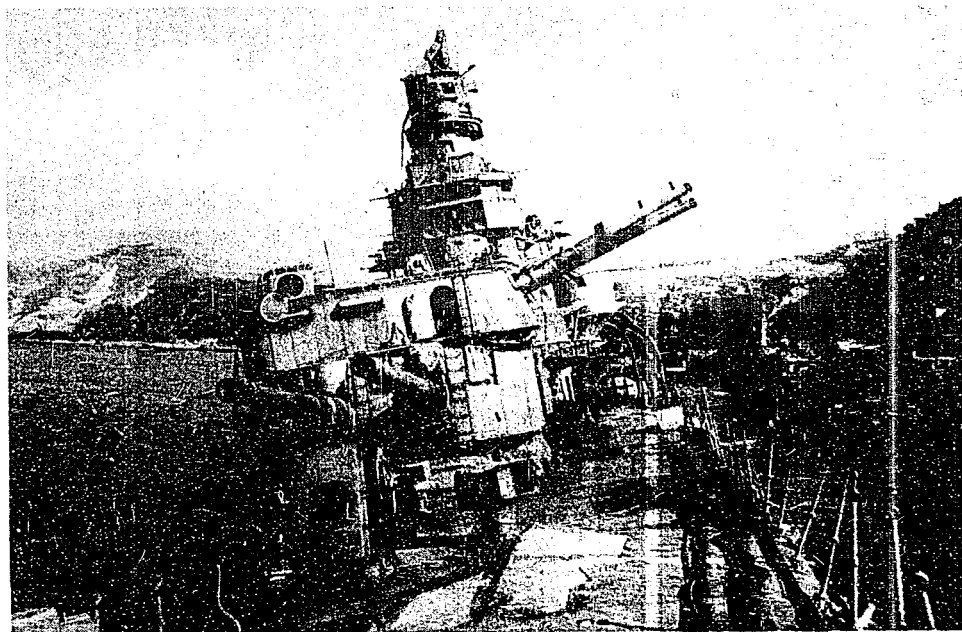
Figure 23
Looking aft from eyes of ship.

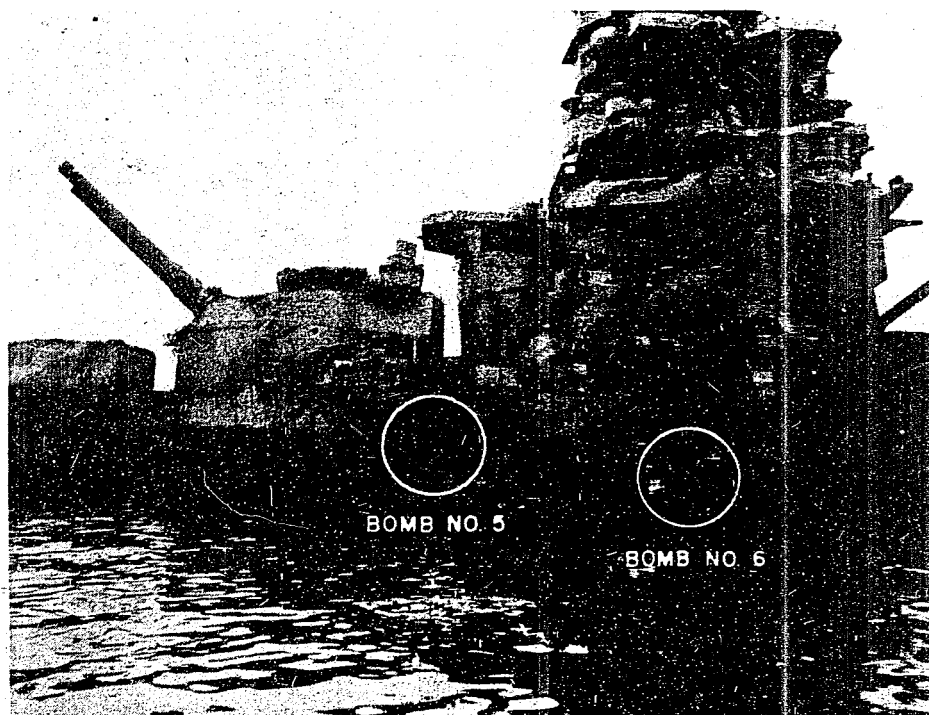
12. Bombs Nos. 5 and 6 struck the port side in way of the foremast tower (Figure 31). No. 5 blew a 15-foot diameter hole in the shell (5/8 inch M.S.) above the armor belt. It penetrated a few feet prior to detonation, as indicated by the outward projection of the torn plate edges. This damage was consistent with a 500-pound G.P. bomb, fuze "non-delay" or 0.01 sec.

*Figure 31
Impact points of Bombs No. 5 and No. 6*

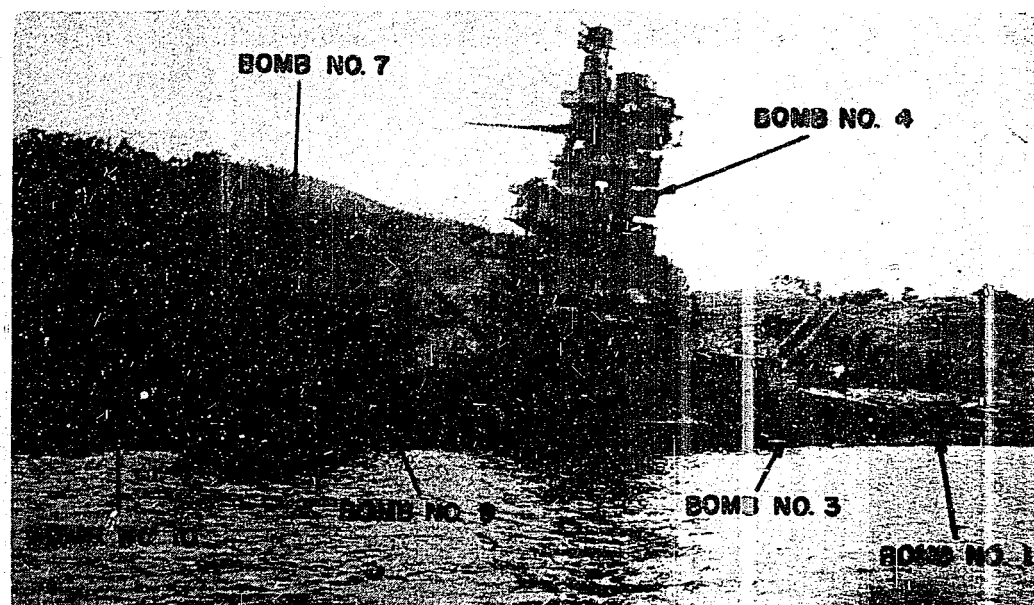
6. Bombs Nos. 4 and 10 inflicted topside damage. No. 4, an instantaneously fuzed bomb, struck the forward tower structure on the O5 level above the pilot house (Figure 32). It is believed to have been a 500-pound G.P. bomb, inasmuch as only superficial damage was caused. However, fragments cut many fire control cables serving the main battery director and AA directors. There was no fire.

7. Bomb No. 10 struck the roof plate of No. 3 turret (Figures 32, 33, and 34). The point of impact was at the juncture of the roof plate with a telescope hood (2½ inch N.C. armor) on the turret centerline. The hood was blown completely off, as were similar hoods on the left and right edges of the turret roof. The roof plate, of 6-inch N.C. armor, was not directly penetrated, but a crack starting at a horizontal bolt hole (by which the hood was secured to the roof plate) resulted in a 9-inch diameter plug being knocked out of the roof plate. The plug and large bomb fragments which passed downward through the opening for the hood wrecked the center slide and trunnions for both guns, effectively putting both guns out of operation. Large fragments also scarred both gun barrels to a depth of two inches. The bomb, either instantaneously fuzed or a high order deflagration, is believed to have been a 1000-pound G.P. judging from the diameter (about 3½ feet) of the puddled area on the roof plate and the depth of fragment scars (some were two inches deep).

Figure 32
Starboard side.

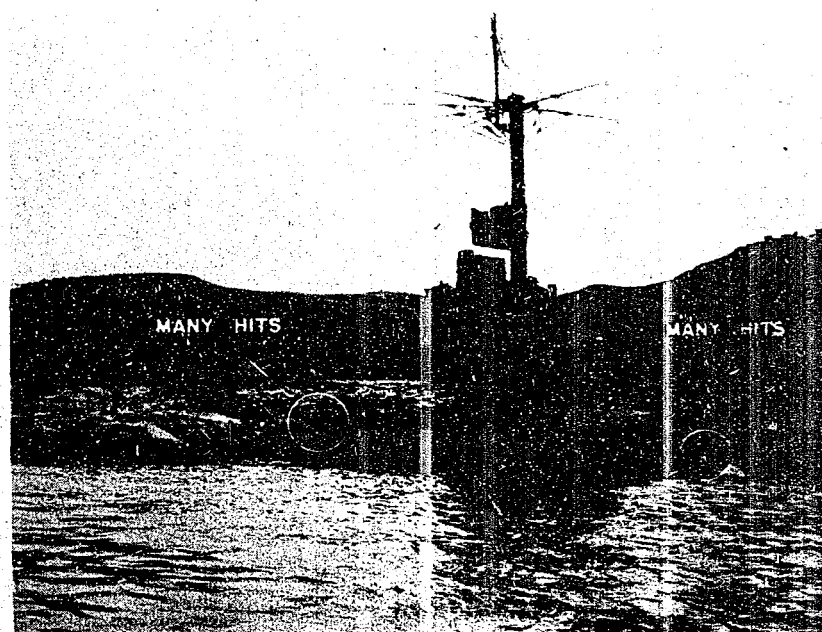
Figure 35

15. Several bombs hit the flying deck on the starboard side somewhat aft of the mainmast tower (see Figure 35). Some were fuze to penetrate and some detonated on impact. As a result the flying deck was demolished over a wide area, and the damage extended down to the second deck, permitting complete flooding of second deck spaces under the flying deck.

16. Again several bombs struck the main deck just forward of the flying deck on the starboard side (Figure 35), demolishing all structure down to the second deck to starboard of the centerline. Flooding occurred throughout this area when the second deck went under.

Looking down to port in way of mainmast.

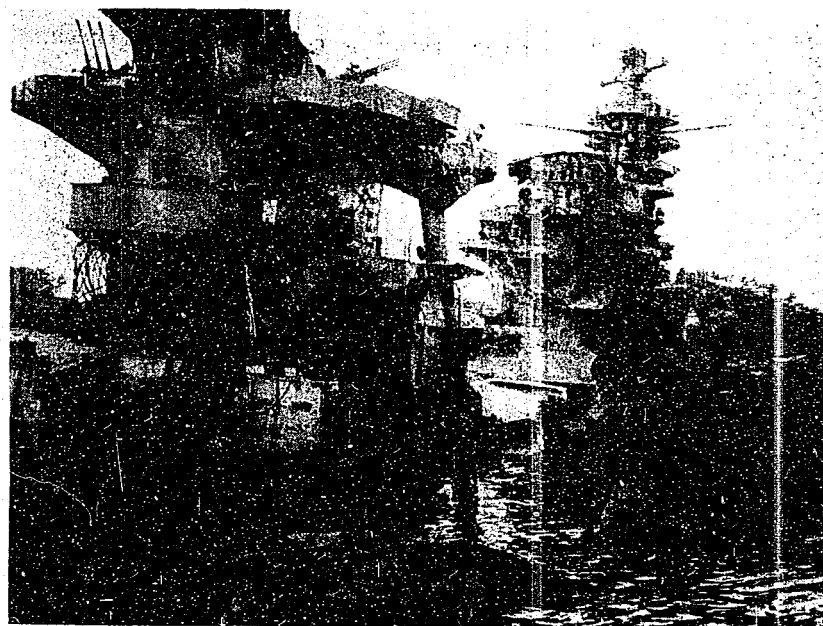
Figure 36

Looking forward on starboard side from flying deck. Many bombs struck in this area. (See Figure 35.)

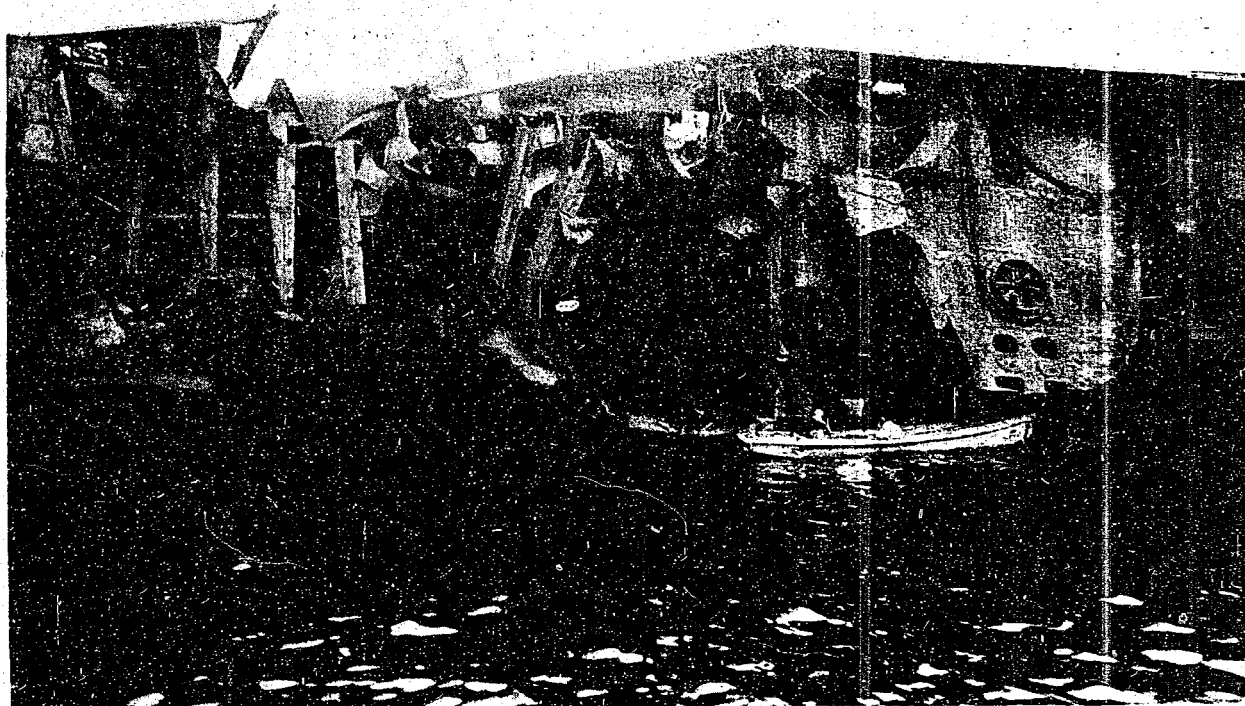
14. The remainder of the bombs all hit in the vicinity of the mainmast tower and on the flying deck. Only one of these could be tentatively segregated from the remainder (see Figure 38). This was a large bomb which hit the port quarter between the flying deck and the waterline, demolishing an enormous portion of the shell from the deck to below the waterline. It was either a 2000-pound G.P. bomb, or else several smaller bombs hit in this area. Extensive flooding resulted from this damage.

Figure 38
Looking at port quarter, well aft.

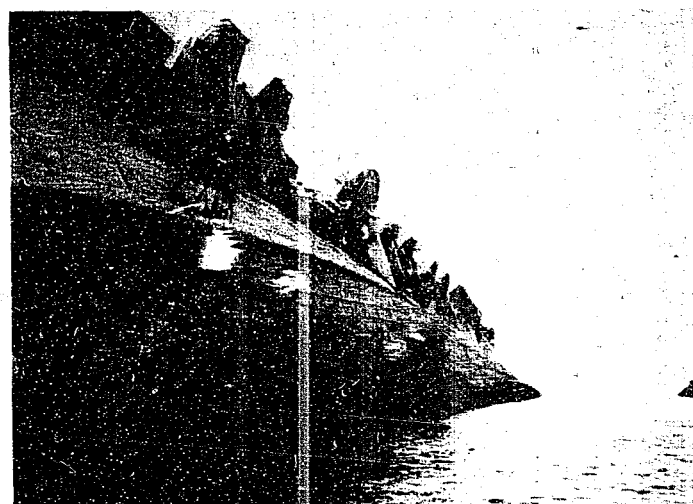
Figure 40
Starboard bottom and side, looking forward.

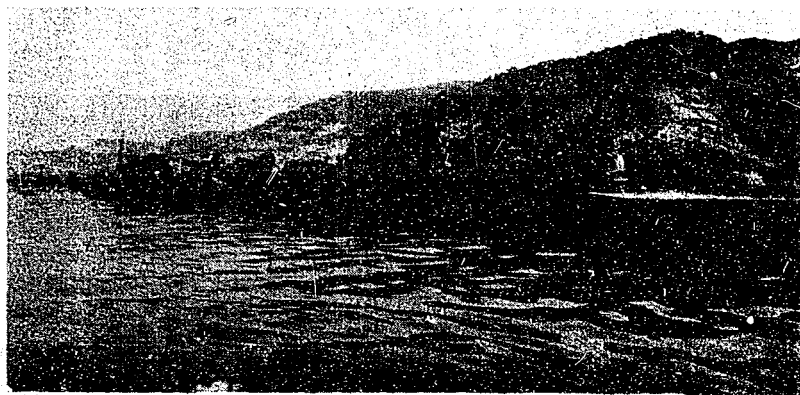
4. OYODO was moored off the westward shore of the island of ETA JIMA, some 10 miles from Kure Naval Base, where she was sunk. She was inspected on 29 November, when she was lying at an angle of 80° from the vertical, in about 25 feet of water, with her port side exposed (Figures 48 and 49). Her position was such that it precluded a diver's examination of the damaged starboard side in a reasonable length of time. Thus the cause of her capsizing is unknown in detail, although the general picture is well-authenticated from Japanese reports.

Figure 48
Looking aft.

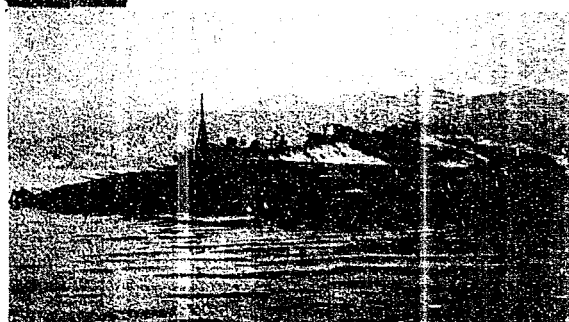
8. During the afternoon, after OYODO was lying on her starboard side with the port shell above water, she was exposed to attack with 5-inch rockets. Two struck her as shown in Figures 50 and 51. The forward one, Figure 50, detonated on impact against a 1/2 inch Ducol Steel plate, at about the location of the waterline. A hole about two feet in diameter was blown in the plate. A noteworthy fact was the absence of interior fragment damage. A bulkhead parallel to the shell, and about three feet inboard was not attacked by a single fragment. The other rocket detonated on impact with a 3/4 inch Ducol Steel plate at a point about 20 feet aft of the forward rocket. As will be noted in Figure 51, the hole in the shell was about the same size as that caused by the forward rocket, despite the heavier plate thickness. Again there was no interior fragmentation, as evidenced by inspection of the space behind the shell.

Figure 50
A typical 5" HVAR
rocket hole in 1/2"
plate. Rocket struck
ship after she had
capsized.

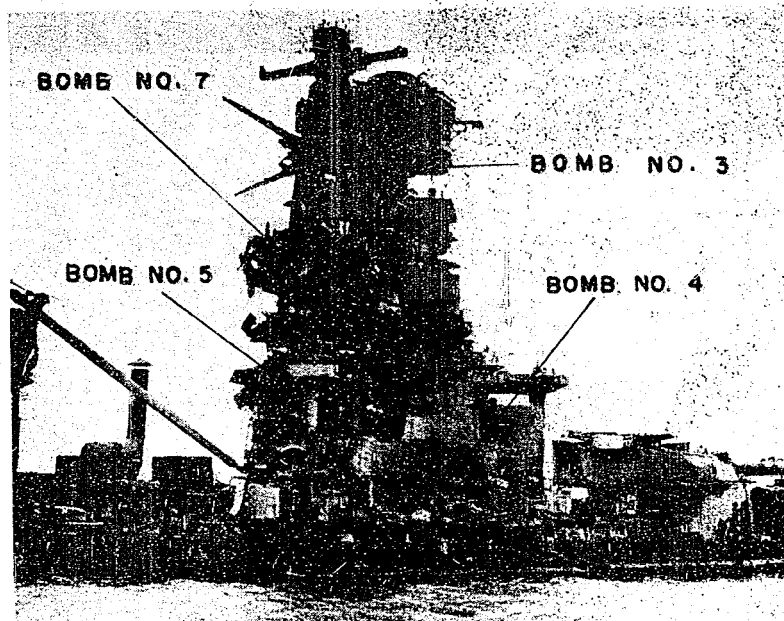
Figure 61

Showing four bomb hits on starboard side of foremast tower, 500-pound GP bombs, instantaneously fuzed. Started bad fire which gutted tower, destroying all fire control apparatus located there.

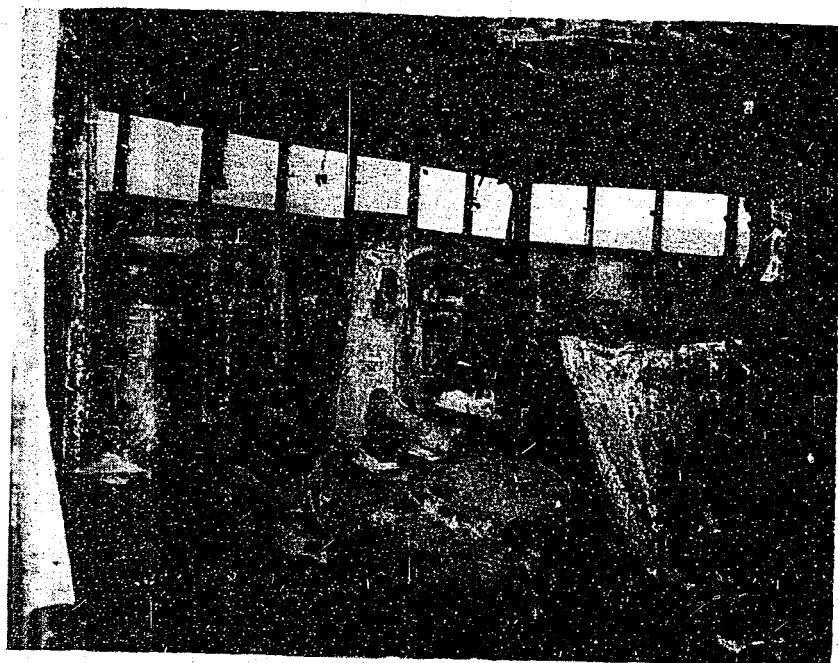
Figure 63
Pilot house, looking forward.
Completely gutted by fire.

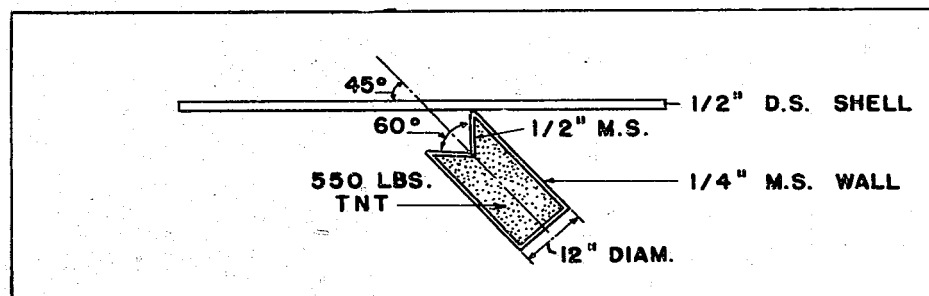
4. Test No. 1 (Figures 67 and 69) consisted of the static detonation of 250kg (550 pounds) of TNT against the port shell in way of 1/2 inch D.S. plate. The charge was cylindrical, 300mm (12 inches) in diameter, with an inverted cone angle of 60° in the nose. It was placed against the shell in such a position that the axis of the charge was at an angle of 45° to the plane of the shell plate. The arrangement is shown below.

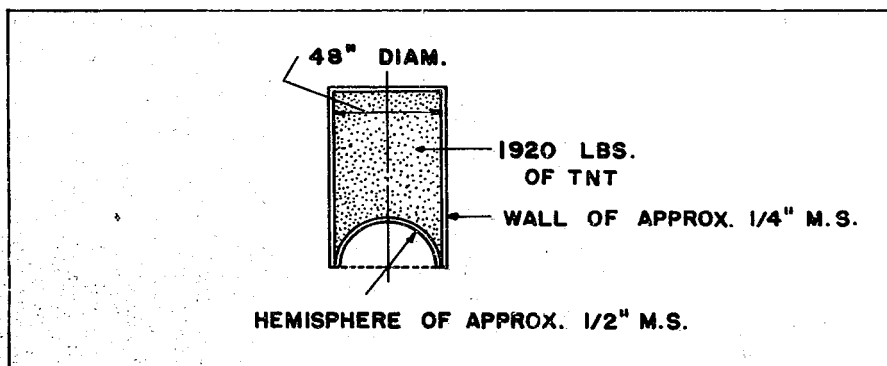
7. Test No. 2 consisted of the static detonation of 900kg (1920 pounds) of TNT about 30 feet forward of the extreme stern. The charge had the following characteristics:

8. The charge was mounted nose down on a scaffold, and 15 feet in the air, above the deck - the distance the flight deck was to have been placed above the hangar deck. The test was to simulate a vertical dive by a KAMIKAZE into the flight deck.

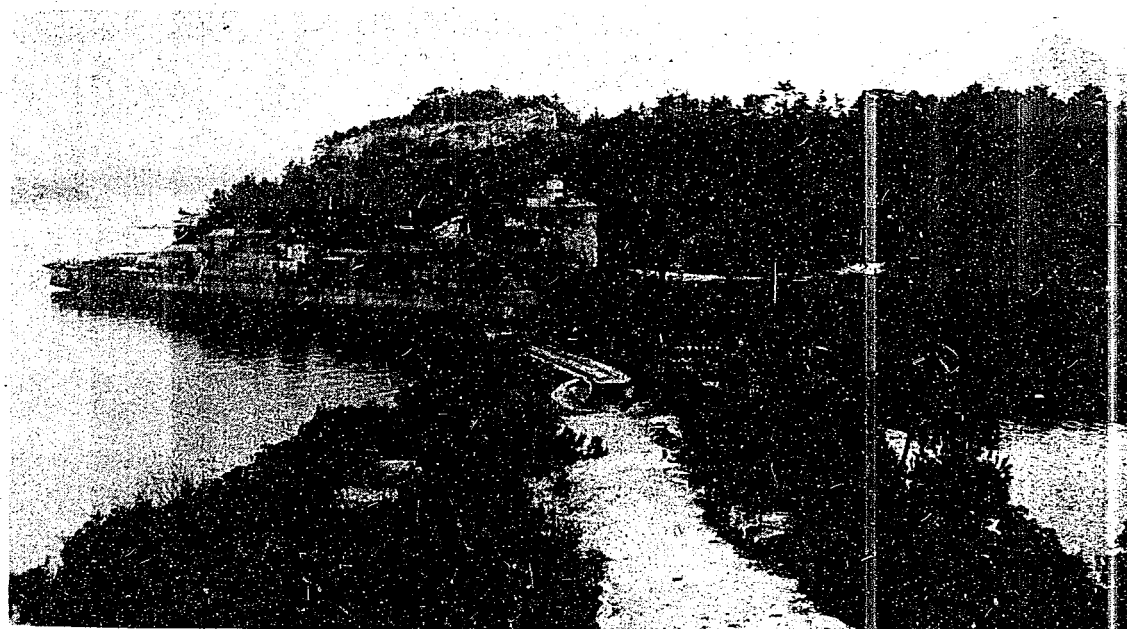
3. The damage described below was received on 7 April 1945 while SUZUTSUKI was a unit of YAMATO's screen in the action south of KYUSHU. She was struck by one bomb and reported damage from two near misses. She proceeded to SASEBO under her own power, although well down by the head. At SASEBO the emergency repairs seen in the photos were accomplished. On 5 May 1945 work was suspended to permit the Navy Yard to concentrate on the production of suicide weapons. She was removed to the small cove shown in Figure 70 and remained hidden there until the U.S. occupation. She was virtually abandoned during the interval.

*Figure 70
Looking along port side.*
