# **Tampa Electric Company - DOE IGCC Project**

**Quarterly Report  
July 1 - September 30, 1996**

RE: Tampa Electric Company - DOE IGCC Project  
July - August - September 1996 Quarterly Report

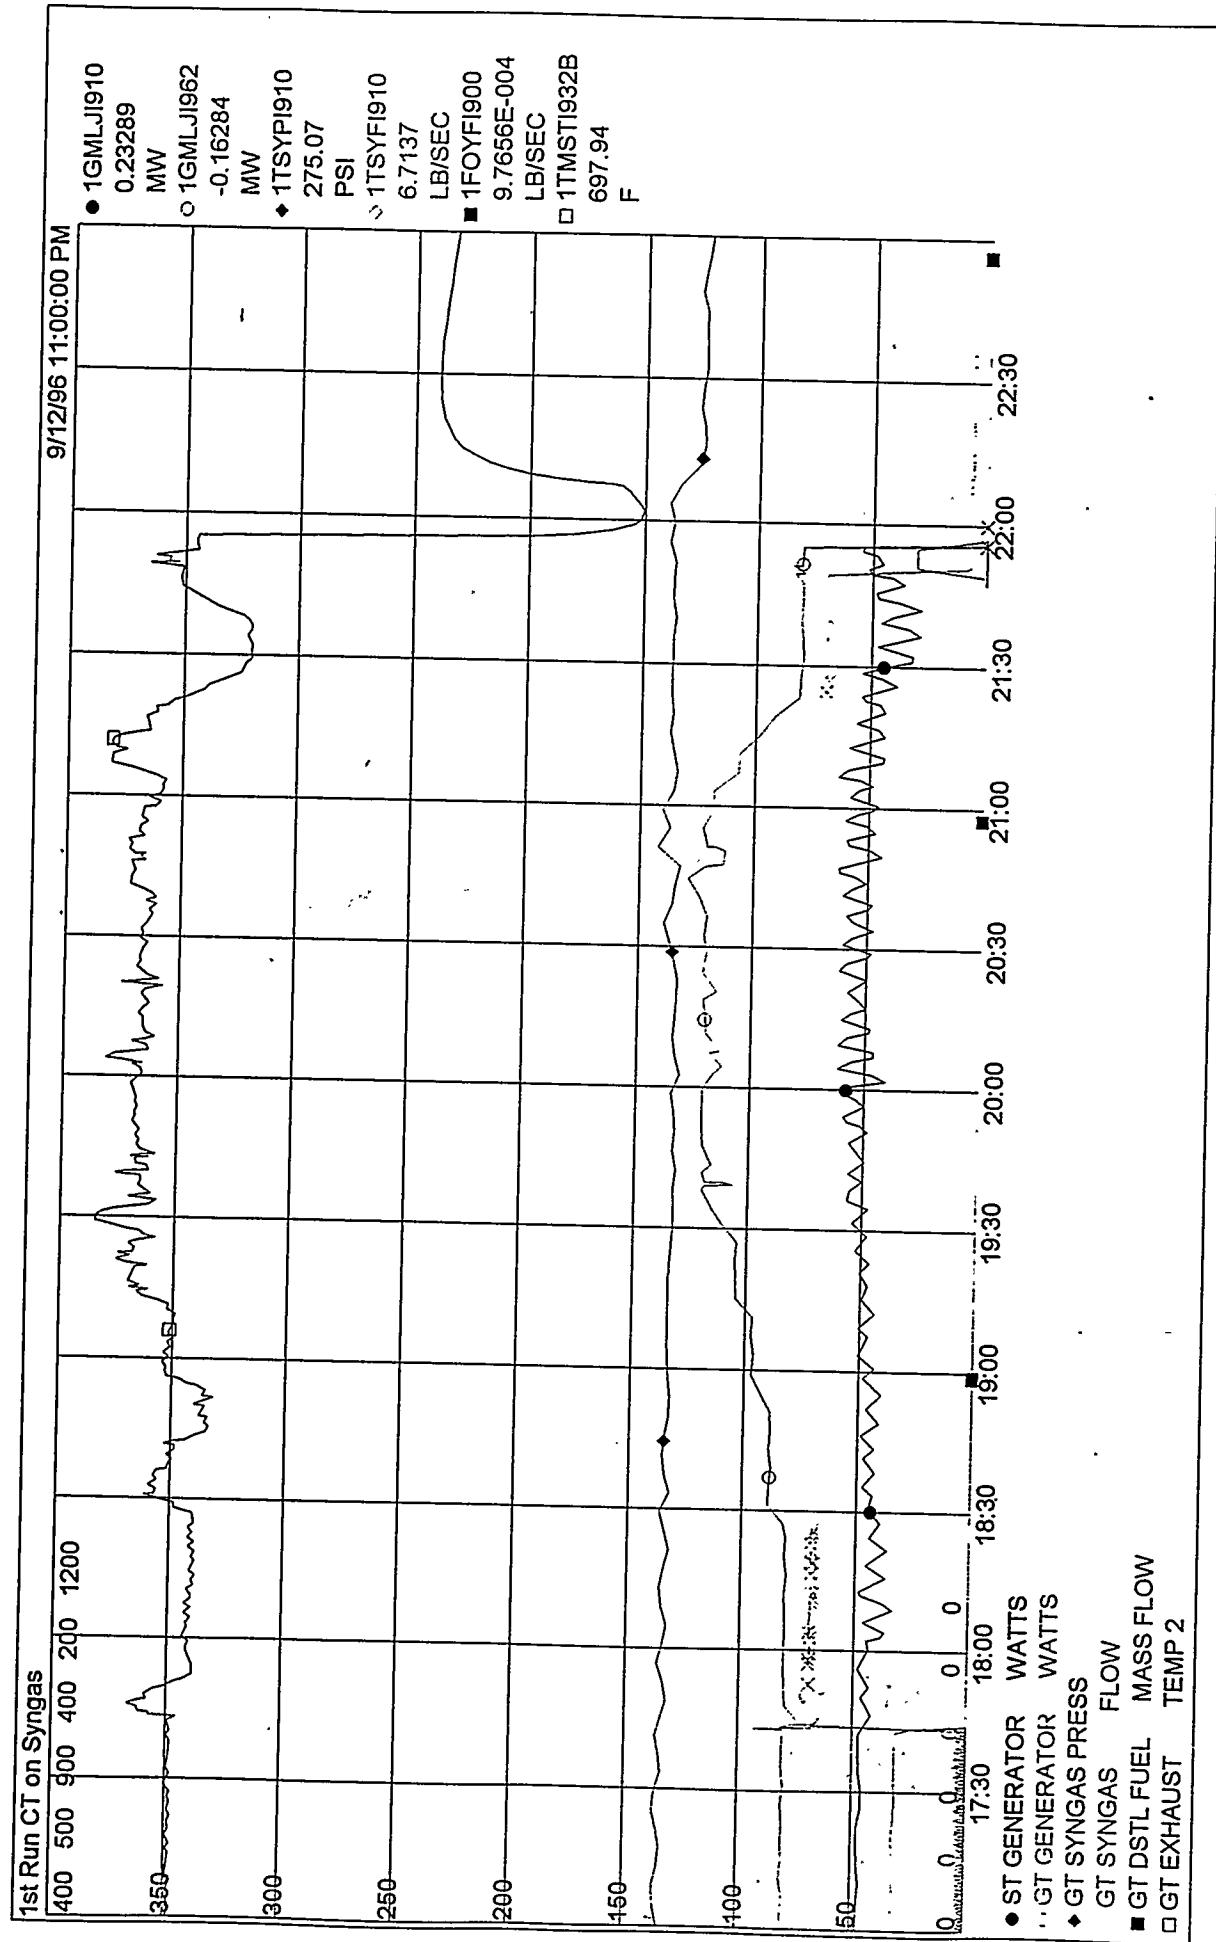
During the third quarter of 1996, the combustion turbine was run on syngas two (2) different times for a combined total of about seven hours. Attachment #4 shows graphically the transfer from oil to syngas. Emission levels were generally acceptable even though no specific emissions tuning was completed by GE and the emissions monitoring equipment was not yet completely operational.
